Platy limestone as cultural heritage

Annex 3.2

Analysis of Platy Limestone Chemical and Mechanical Properties

Istrian Development Agency IDA d.o.o.

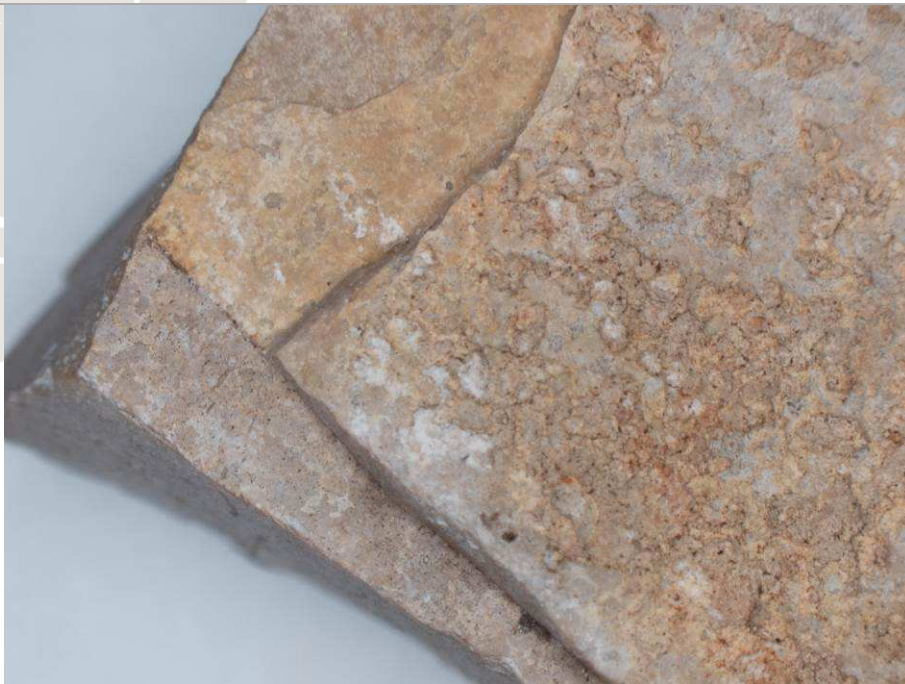
Sample: ID 3400 Grohote – Ruića Dvora - roof (HGI) – Mag. 10X

There are visible some beige-yellowish patinas on the surface of the sample. Degradation by layering is visible and changes in colour of the stone.

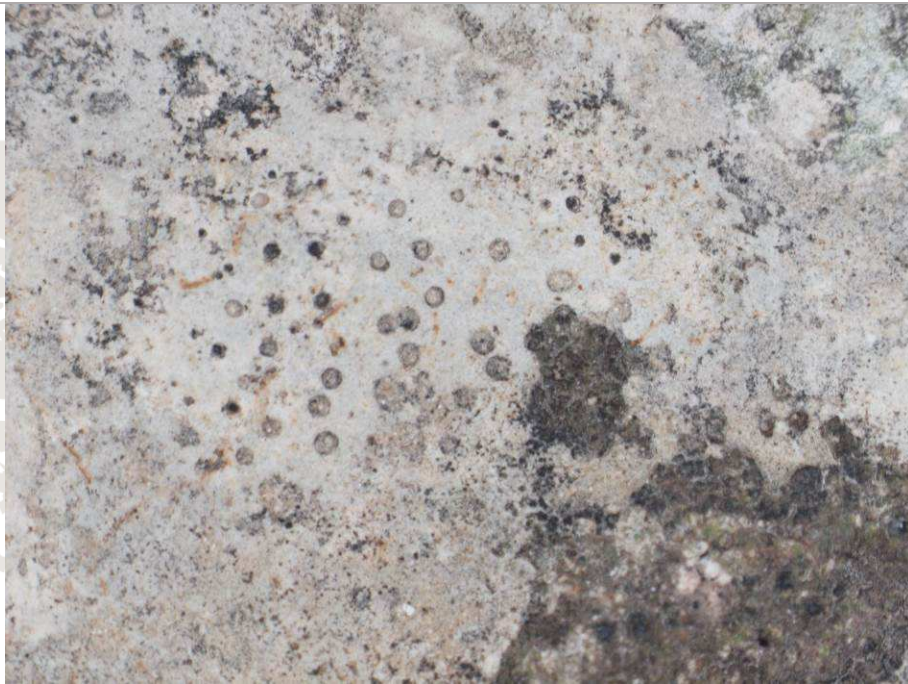
Sample: ZAD 3 Medviđa sv. Ivan Krstitelj – Roof - Mag. 20X.

The biological deterioration concerns only the surface of the sample where are visible endolithic lichens colonies.

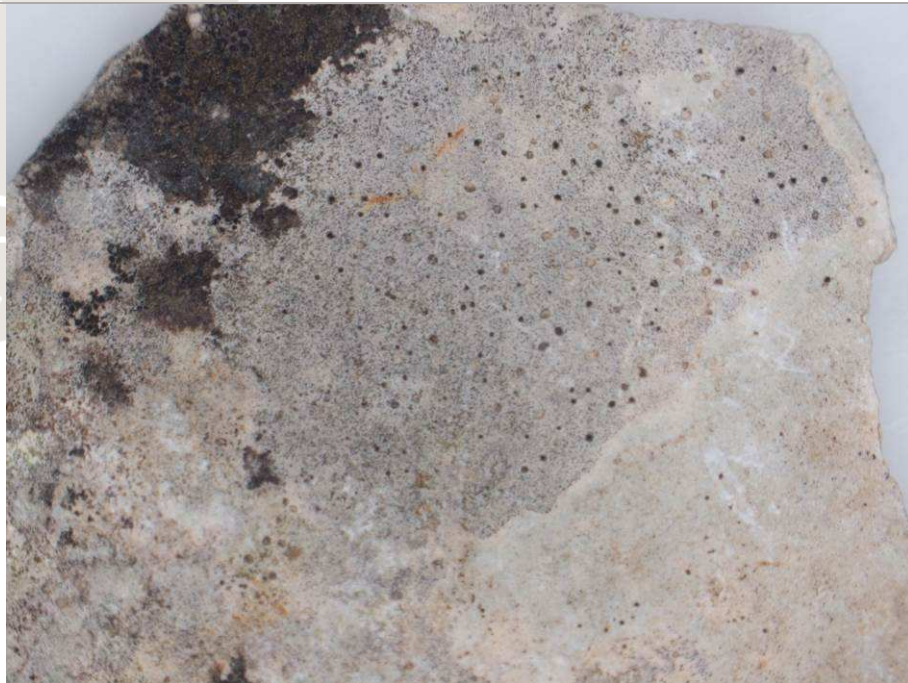
Sample: ZAD 4 Medviđa sv. Ivan Krstitelj – Presbytery - Mag. 10X.

Grey patina and endolithic lichens visible on the surface.

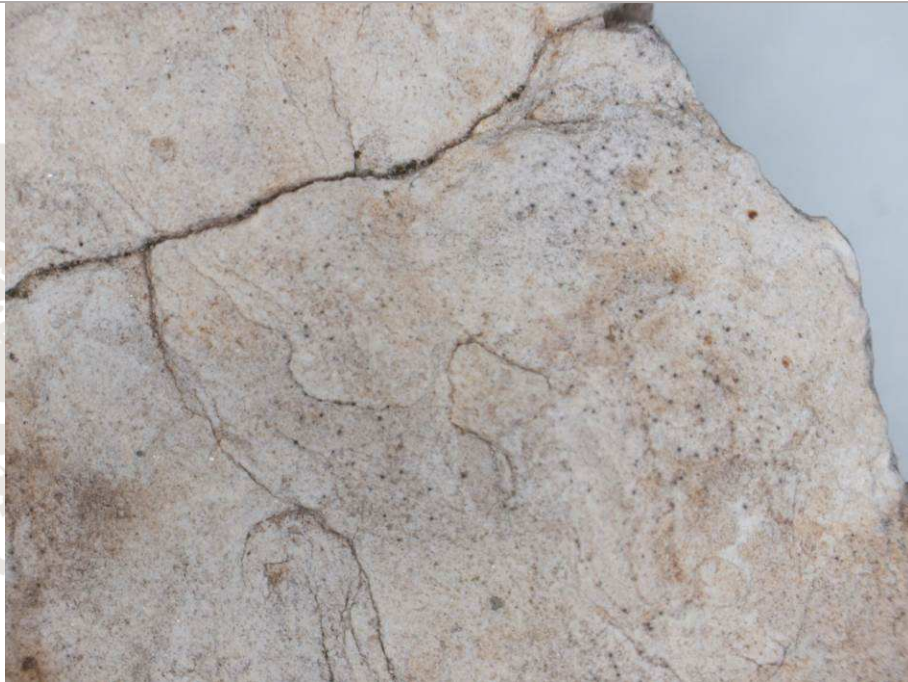
Sample: ZAD 5 Medviđa sv. Ivan Krstitelj – Sidewalk - Mag. 20X.

Structural deterioration is visible on the surface and the bulk of the sample. Endolithic lichens are present too.

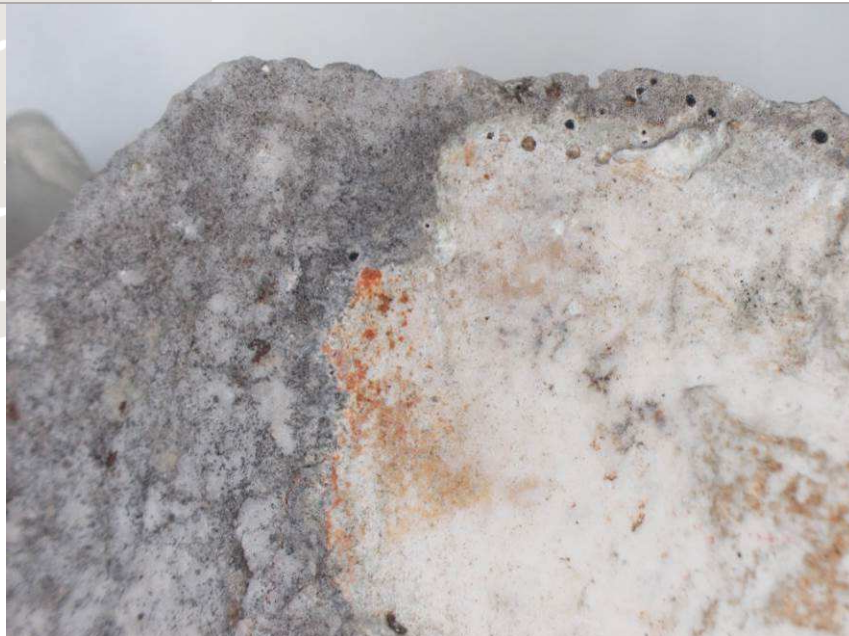
Sample: ZAD 6 Ovča quarry Dugi otok - Mag. 20X.

On the exposed, left, part of the sample, a grayish patina is visible. Holes caused by endolithic lichens are present.

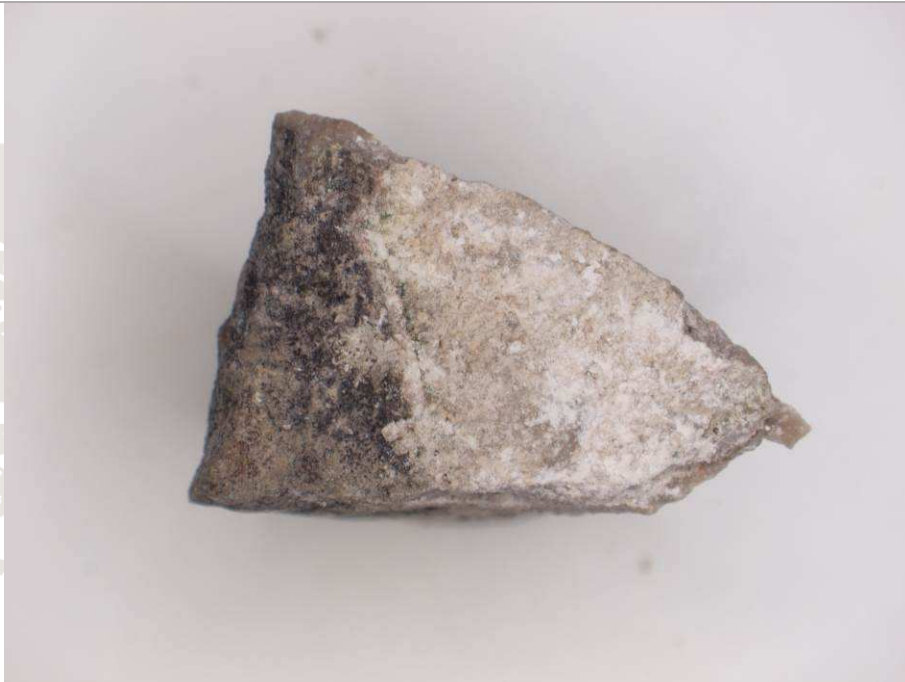
Sample: Slo1 Škrateljnova domačija – Roof – mag. 10X

Degradation by layering and disintegration of material is visible as well as lichens and impurities on the stone surface.

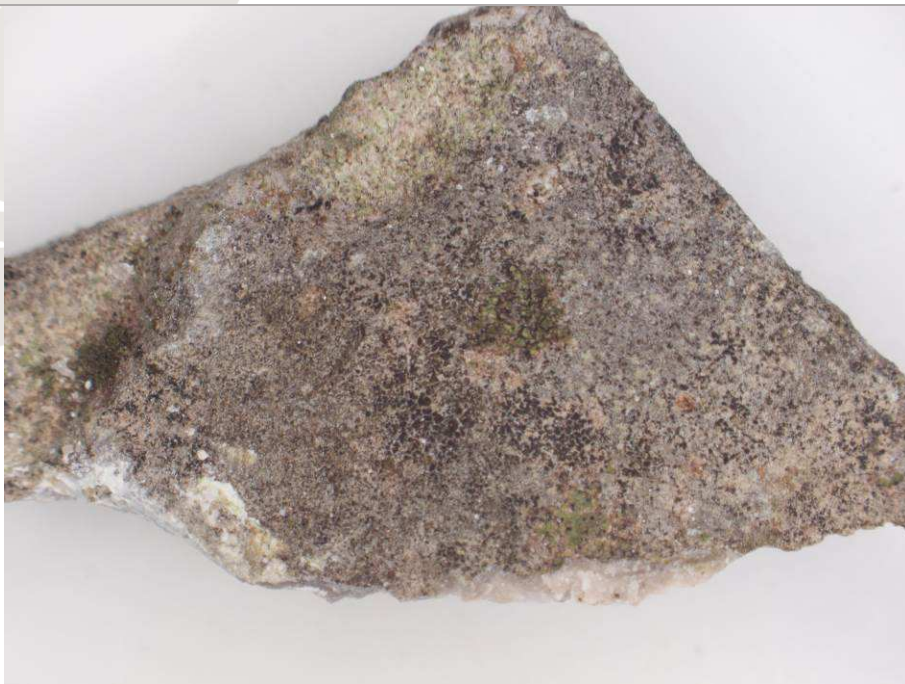
Sample: Slo2 Pri Blaževih – Roof – mag. 10X

Lichens of various typology are visible on the sample surface.

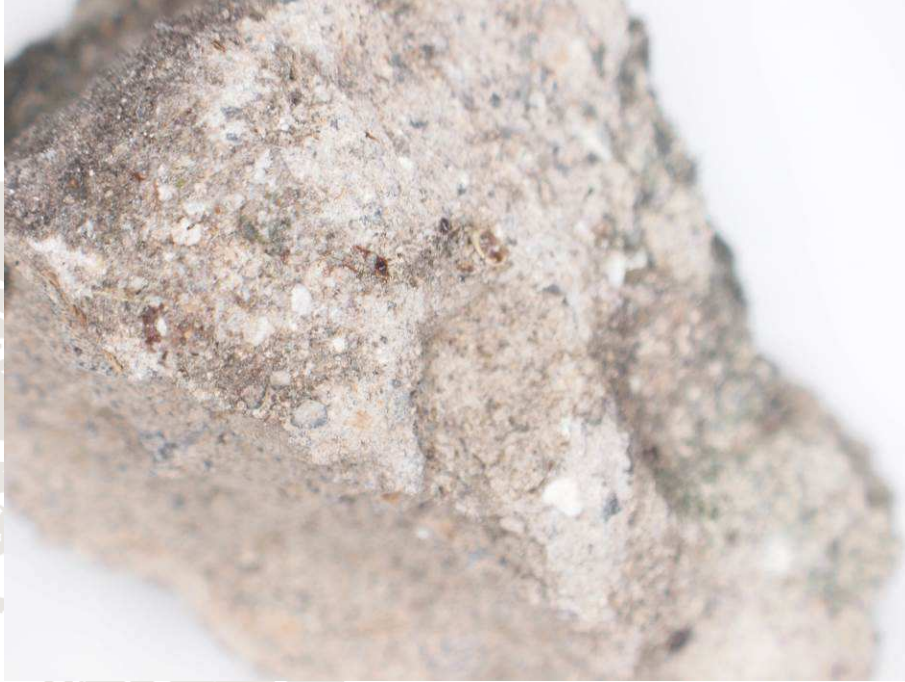
Sample: Slo5 Cerkev Marijinega vnebovzetja – Wall below the presbytery – mag. 10X

It is a sample of mortar. Aggregates and the binder matrix are recognizable.

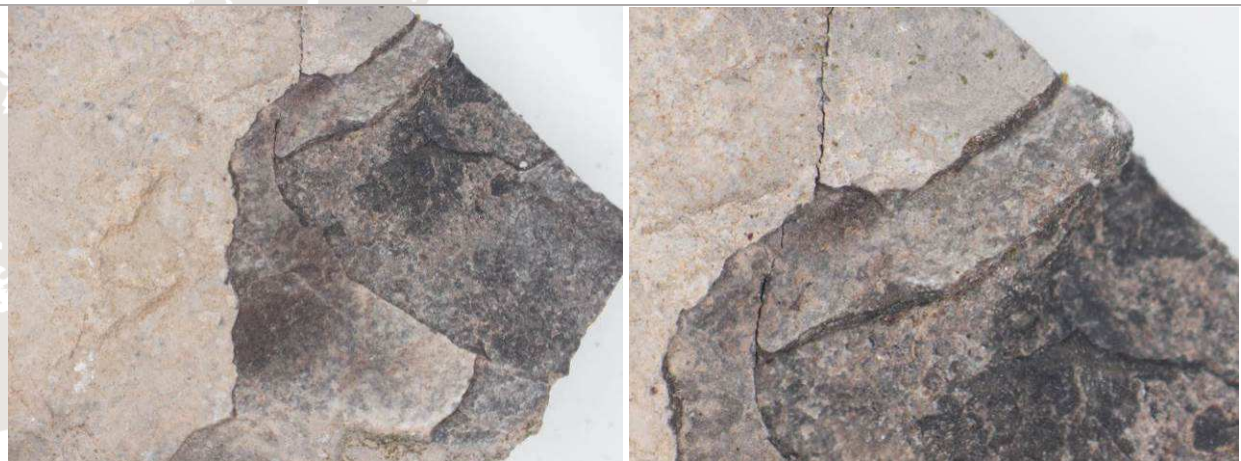
Sample: Slo6 Cerkev sv. Elije – Foundation – mag. 10 and 20X

Significant degradation due to exfoliation and layering is visible. The bulk of the sample has a darker coloration than the surface patina, which may have been altered and decolorized by weathering agents.

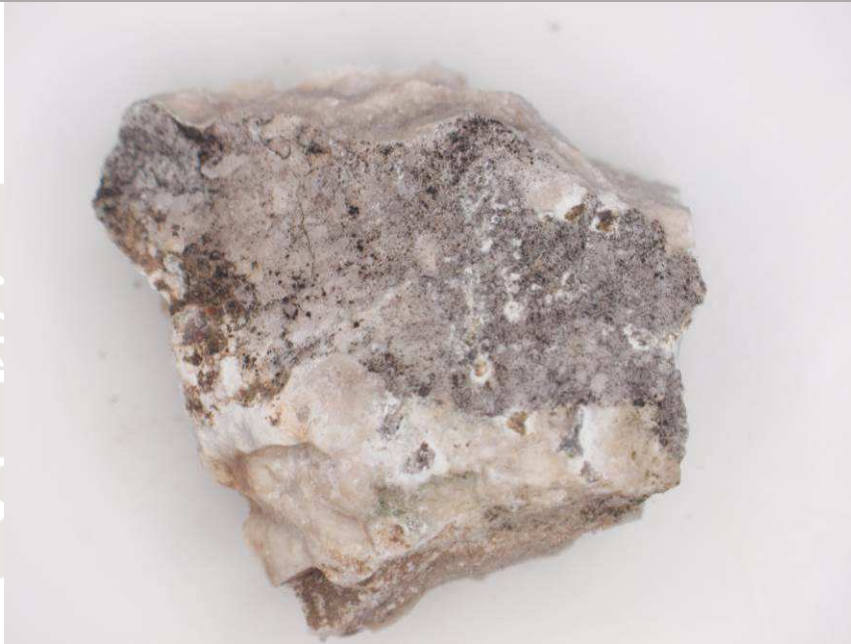
Sample: Ita1 Trebiciano 107 – Roof – mag. 10X

Degradation due to exfoliation and layering is visible as well as lichens on the stone surface.

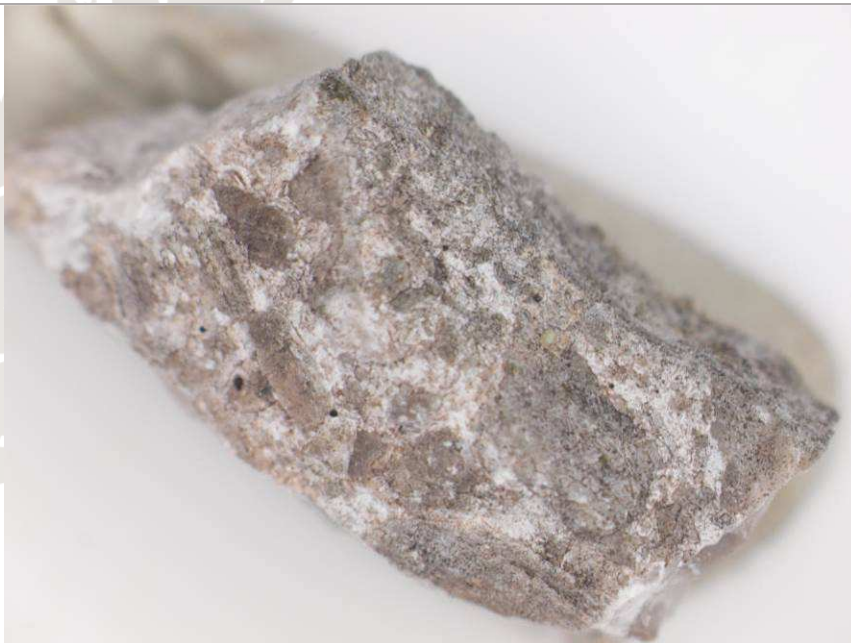
Sample: Ita2 Rupingrande 31 – Roof – mag. 10X

No significant degradations are visible, a greyish thin patina is observable on the exposed side of the sample.

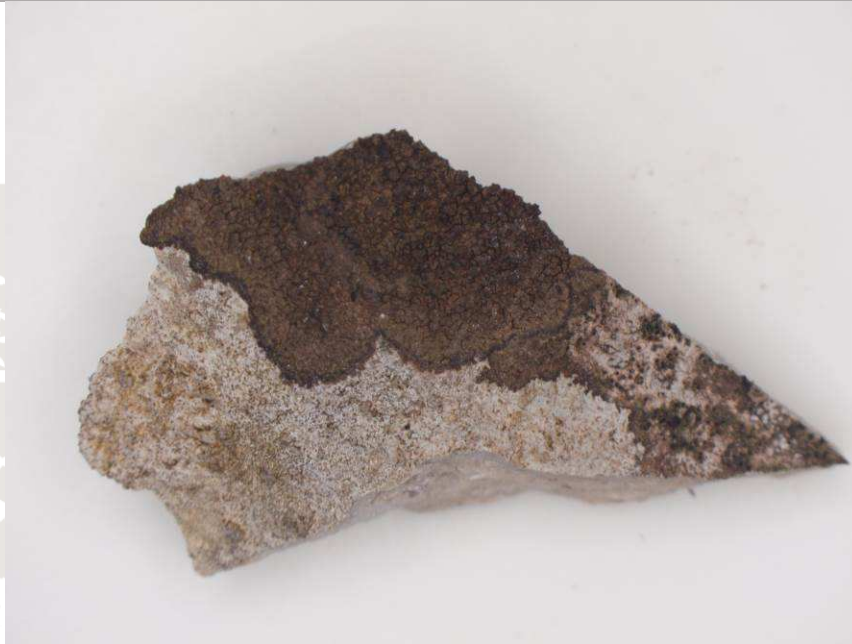
Sample: n1039 Basovizza- Kosovel 28 – Roof – mag. 10X

A thick lichen colony is present on the stone surface of the studied sample.

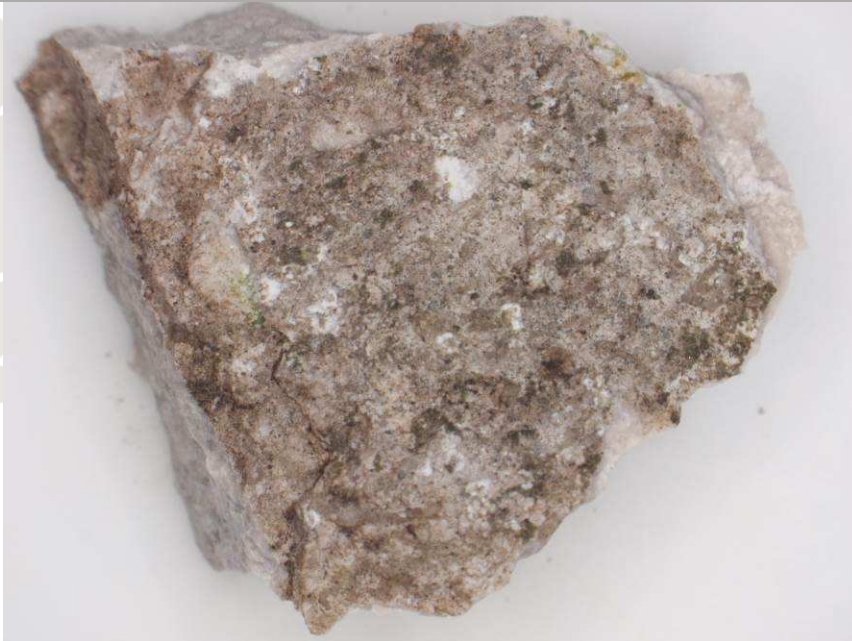
Sample: n1100 Rupinpiccolo 4 – Roof – mag. 10X

No significant degradation are observable on the sample surface. Micro fractures are visible as well as layering of the stone structure.

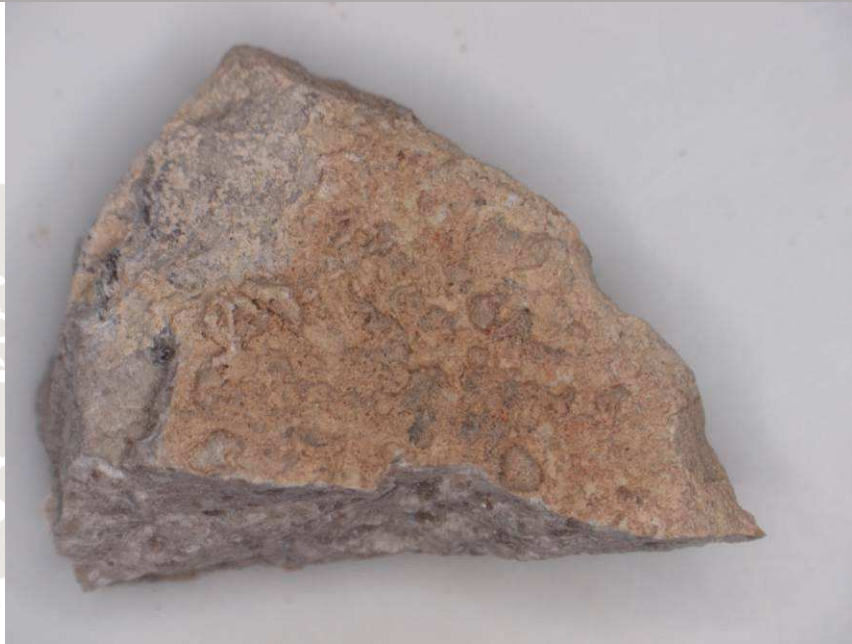
Sample: n1104 Rupinpiccolo 17 – Roof – mag. 10X

A yellowish-beige patina is observable on the sample surface. No biological degradation are present.

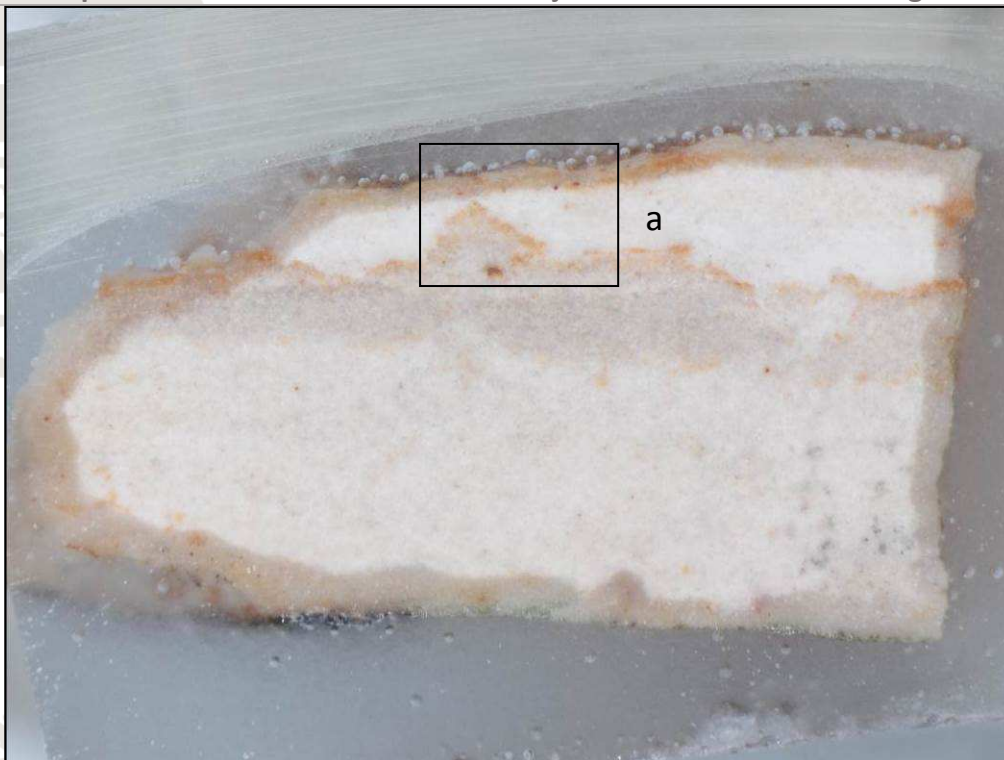
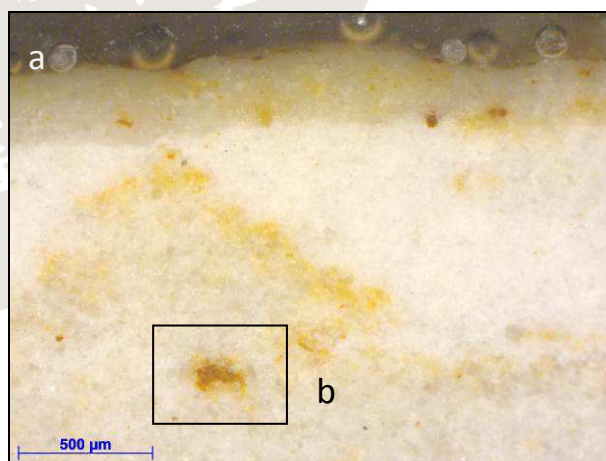
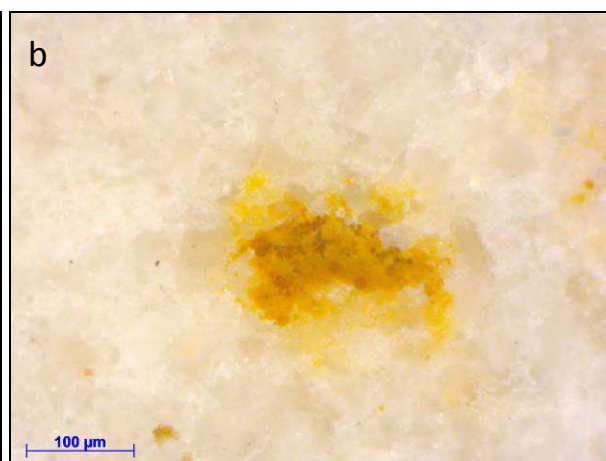
Sample: ZAD 3 Medviđa sv. Ivan Krstitelj – Roof – cross-section Mag. 12X.

Absorption of the transparent epoxy resin by the first 100 to 500 micrometers of the stone structure is visible, which imply that the porosity of the analyzed sample is relatively low. Layers with different colors and alterations in the structure are observable along the sample cross-section. Alterations in color due to the presence of iron oxide crystals are visible as orange stains.

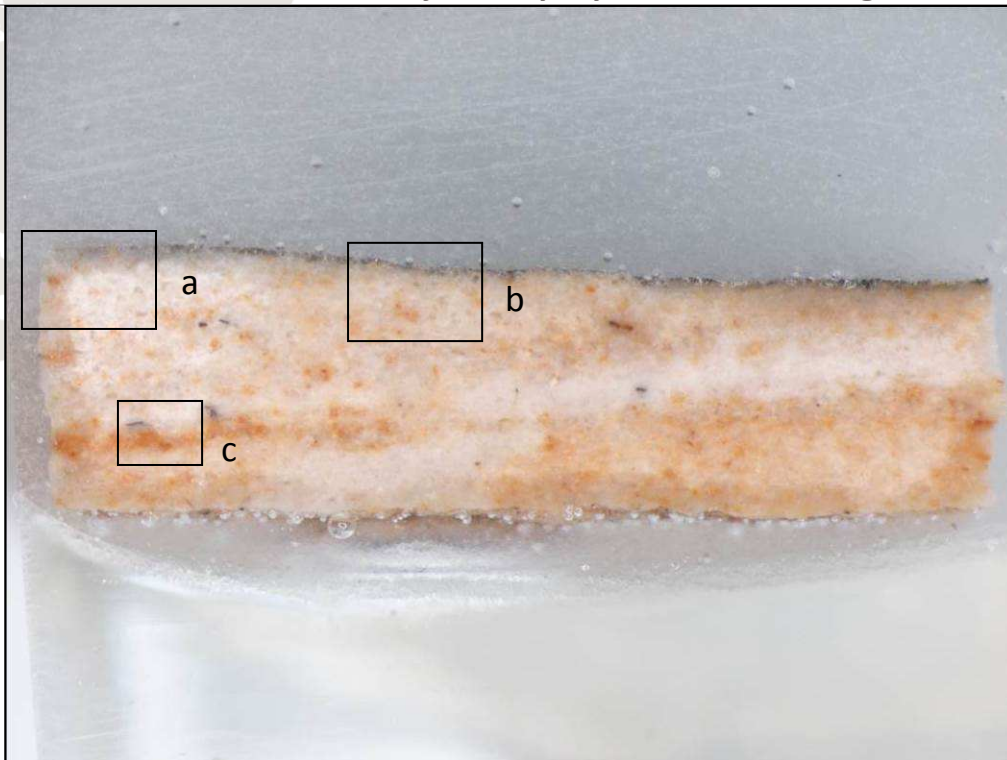
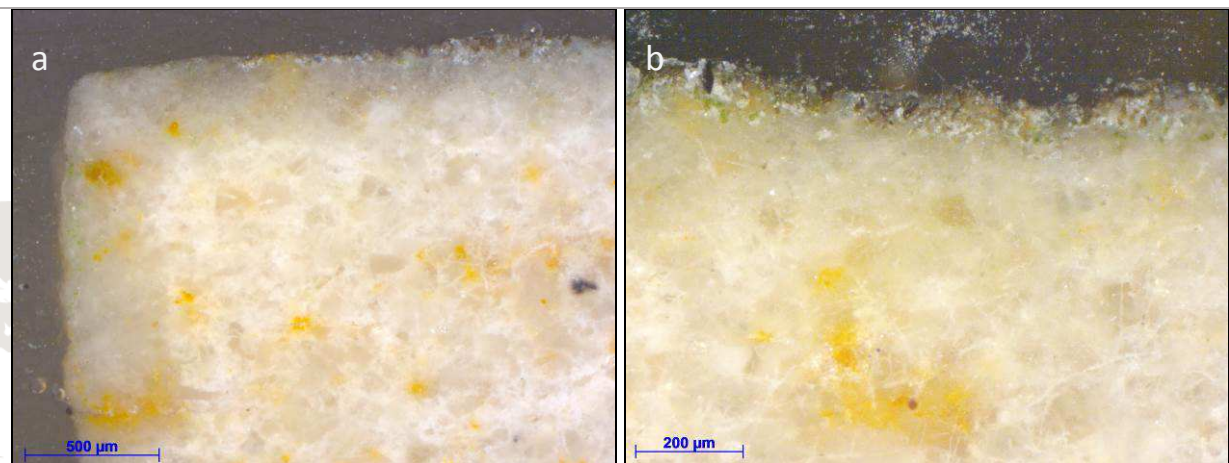
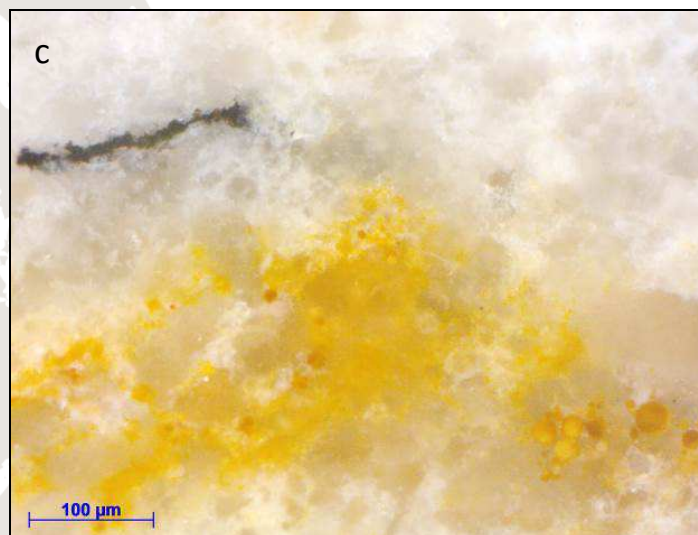
Sample: ZAD 4 Medviđa sv. Ivan Krstitelj – Presbytery – cross-section Mag. 12X.

Absorption of the transparent epoxy resin by the first 100 to 500 micrometers of the stone structure is visible, which imply that the porosity of the sample is relatively low. Layers with different coloration are recognizable and numerous orange stains due to the presence of iron oxide are visible in form of spherical crystals (figure C).

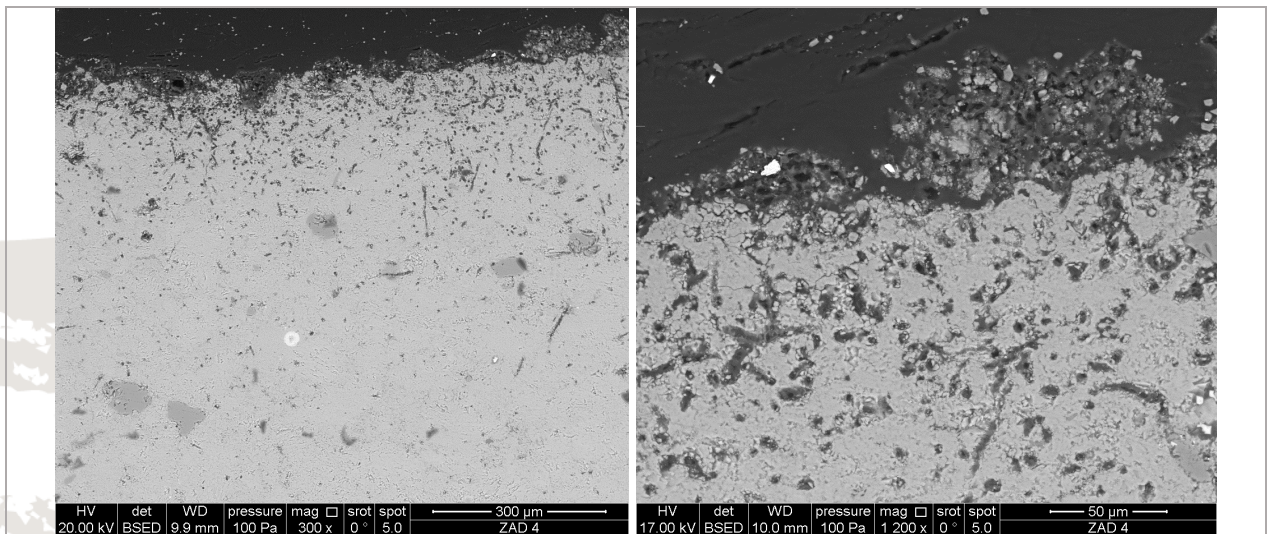
SEM BSE images show a dense layer of hyphae actively penetrating and dissolving the calcite structure.

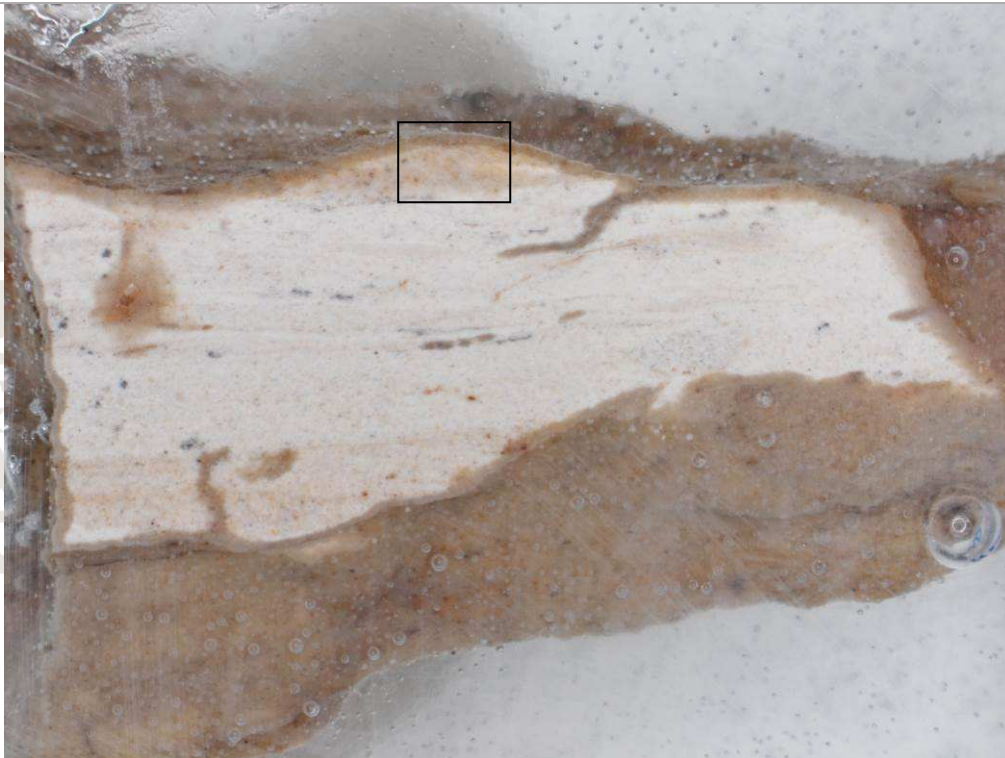
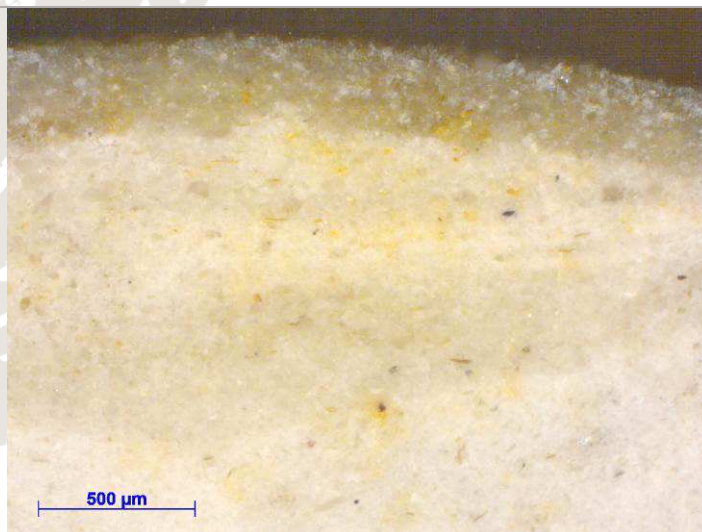
Sample: ZAD 5 Medviđa sv. Ivan Krstitelj – Sidewalk - Mag. 20X

As in the two previous samples, absorption of the transparent epoxy resin in the first 500 micrometers of the stone structure is visible, as well as in the micro-fracture observable in the sample.

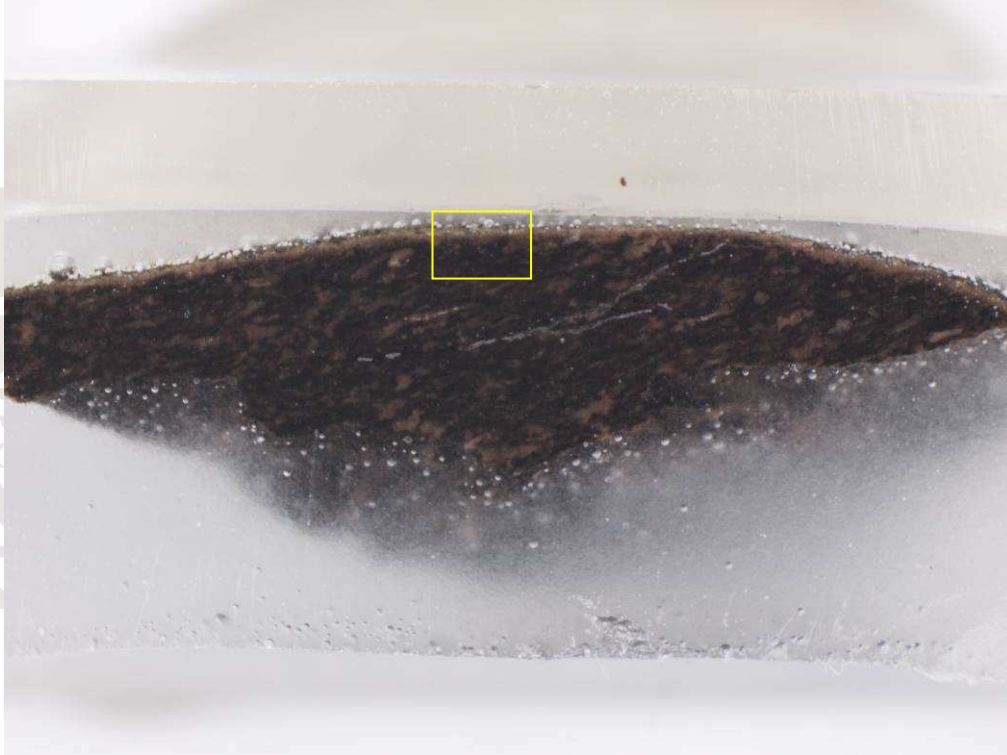
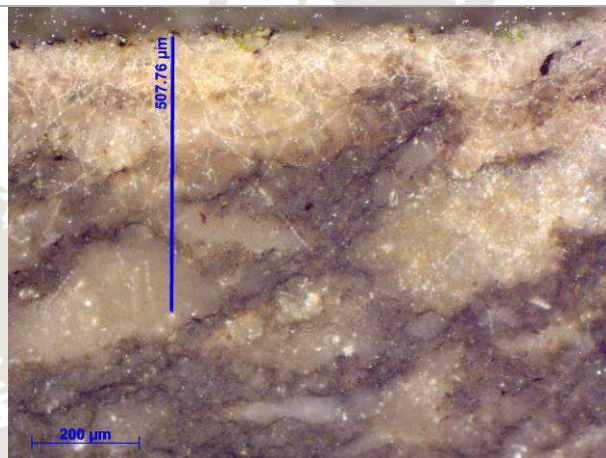
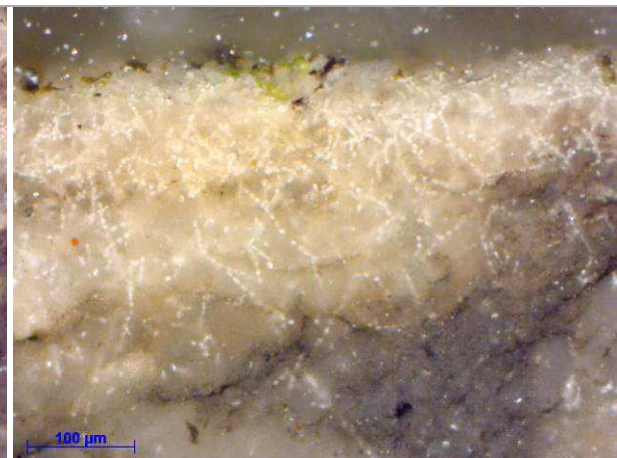
Sample: Slo1 Škrateljnova domačija – Roof – mag. 10X

On the sample it is visible a slightly discoloration of the rock on the surface due to hyphae of endolithic lichens present on the rock surface. The colonization of the studied sample goes up to half millimeter in the rock structure increasing the porosity and damaging the carbonate crystal structure in the affected area. On the surface of the studied sample no noteworthy patina is observable.

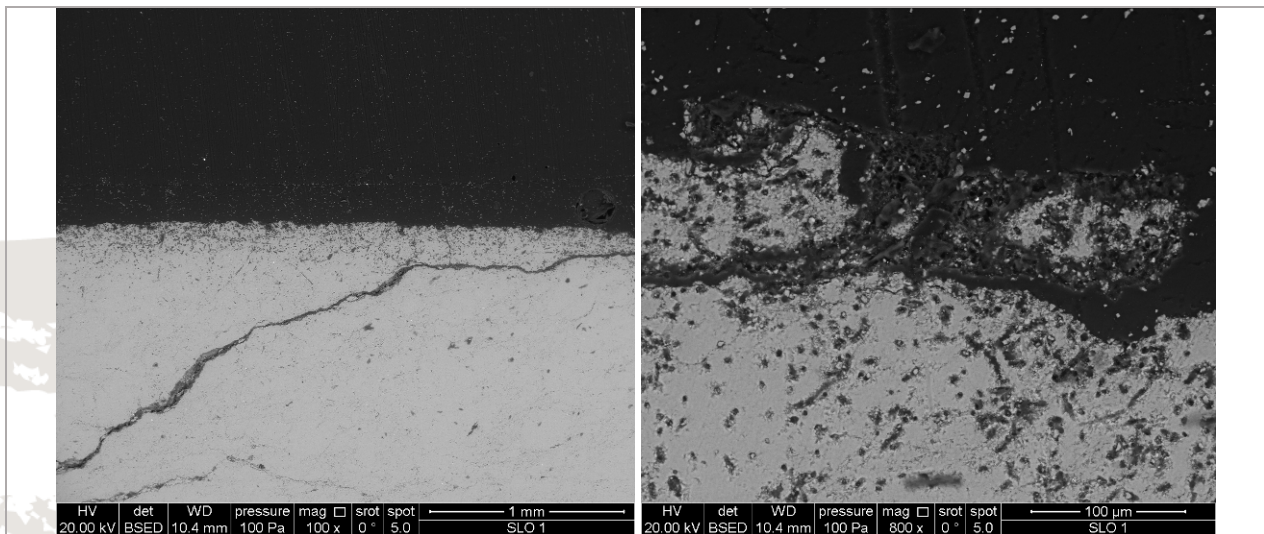
SEM BSE images point out fractures along the analyzed sample and on its exposed surface where damage and detachment of material can be observed due to the activity of endolithic lichens.

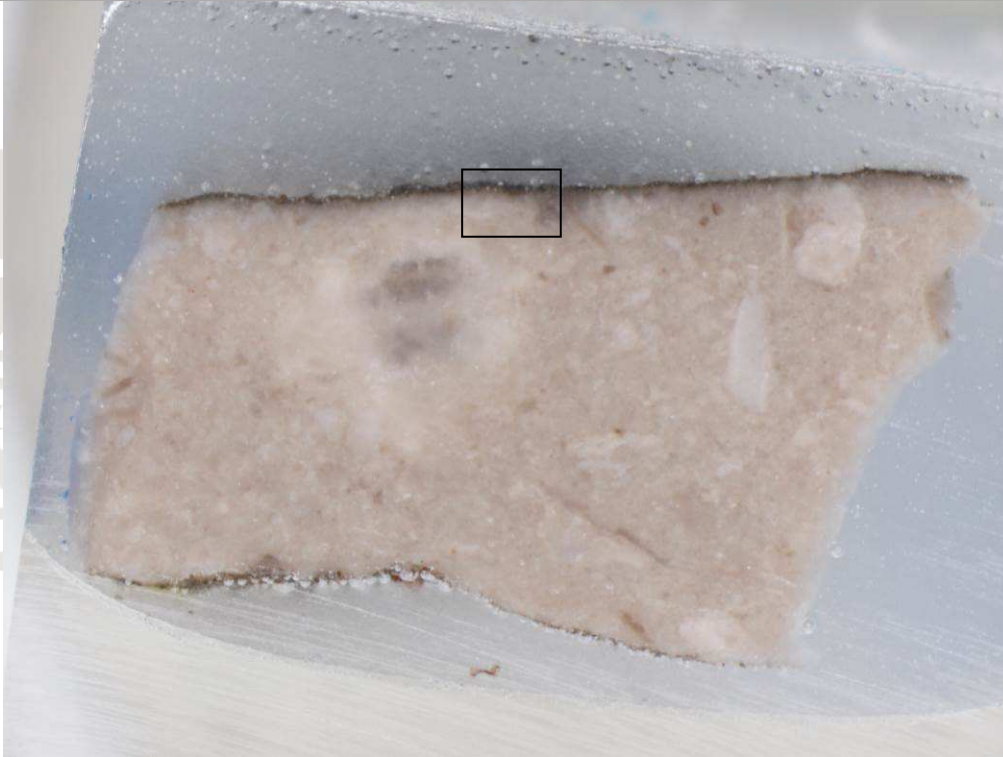
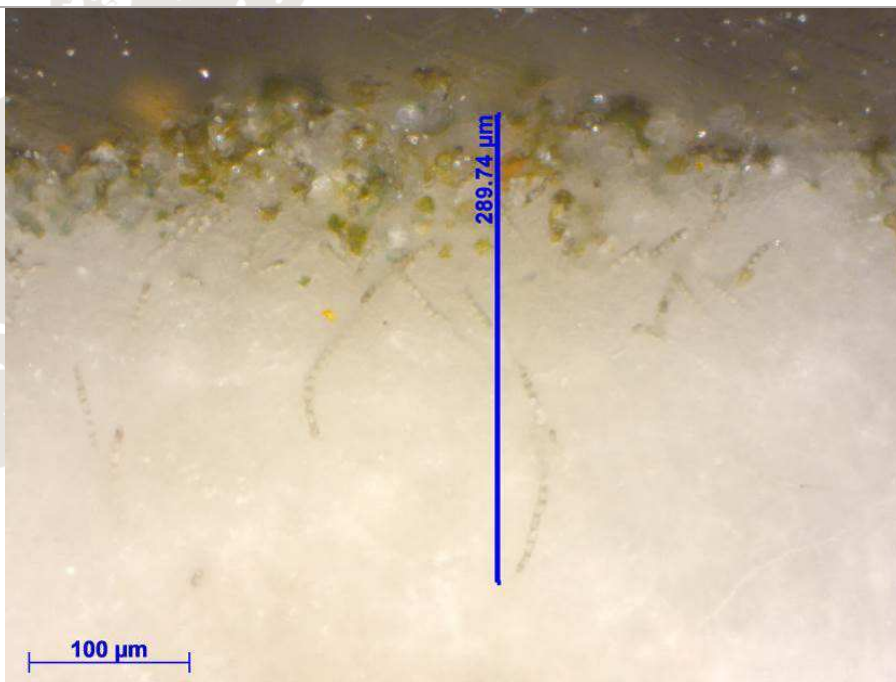
Sample: Slo2 Pri Blaževih – Roof – mag. 10X

A thin greyish patina is visible on the sample surface. A more detailed microscopic analysis showed its biological origin. The lichens hyphae penetrated the stone bulk up to 300 micrometers. On the studied sample no layering is visible.

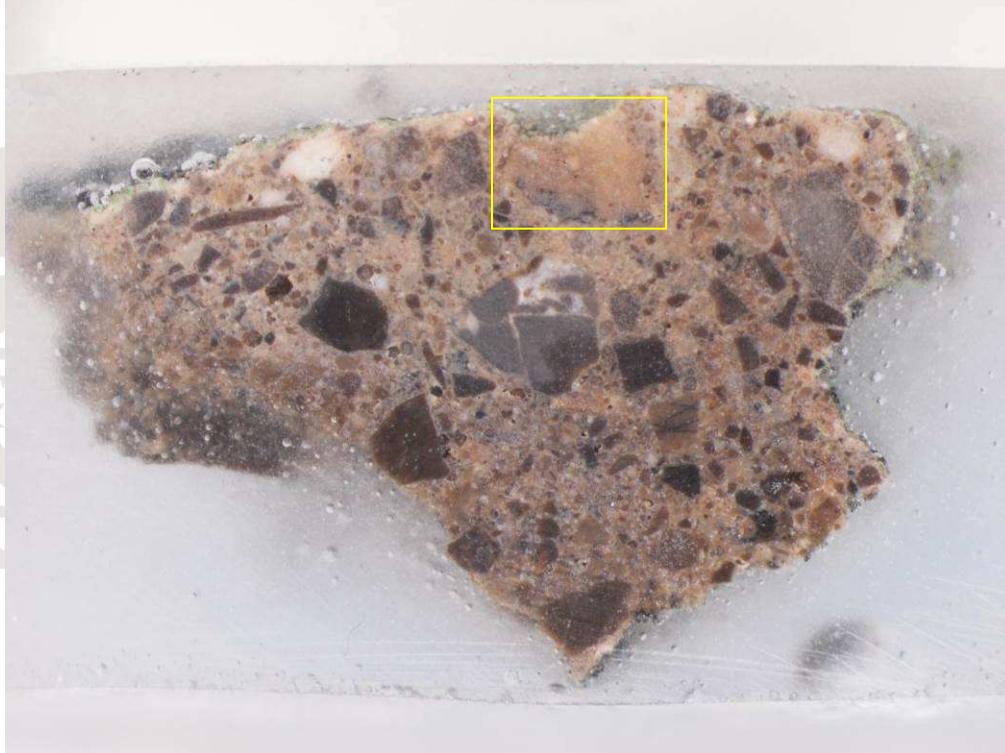
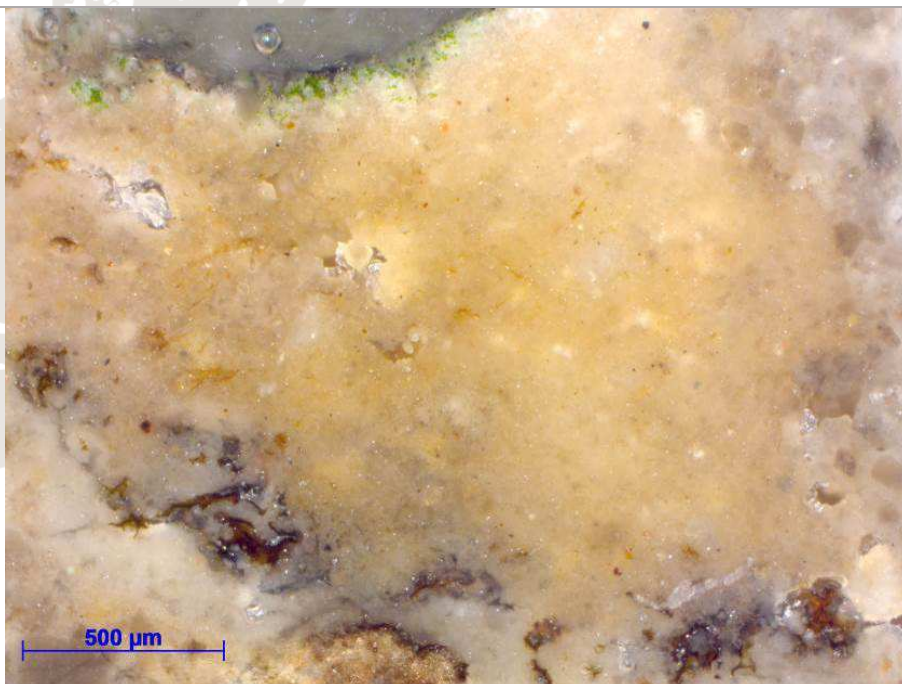
Sample: Slo5 Cerkev Marijinega vnebovzetja – Wall below the presbytery – mag. 12X

The sample studied is a mortar where aggregates and the binder matrix are visible. The aggregates are mostly crushed limestone greyish color. The aggregates/binder ratio is about 50%. On the exposed surface of the sample a green layer is visible due to the presence of lichens.

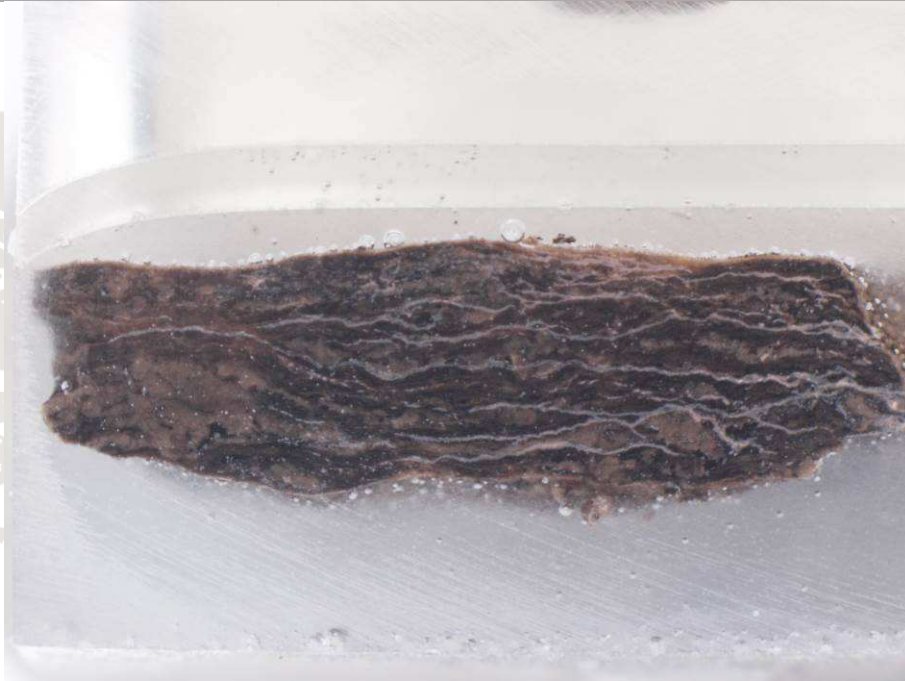
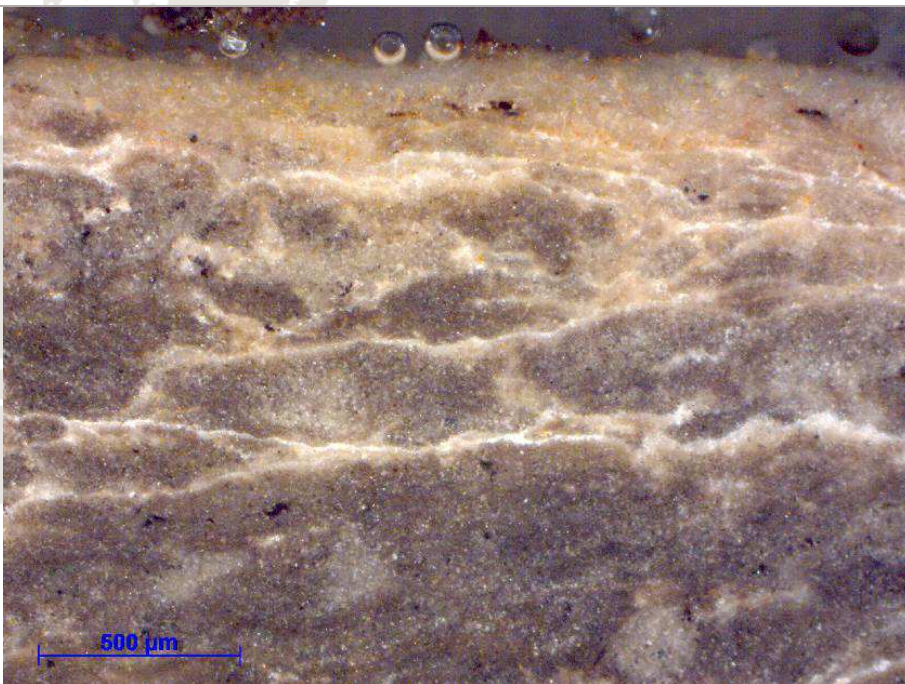
Sample: Slo6 Cerkev sv. Elije – Foundation – mag. 20X

Significant stratification of the lithotype is visible in the studied sample as well as superficial discoloration although any patina of biological origin is present. Orange colored crystals are visible along the first 1000 micrometers of the sample cross-section.

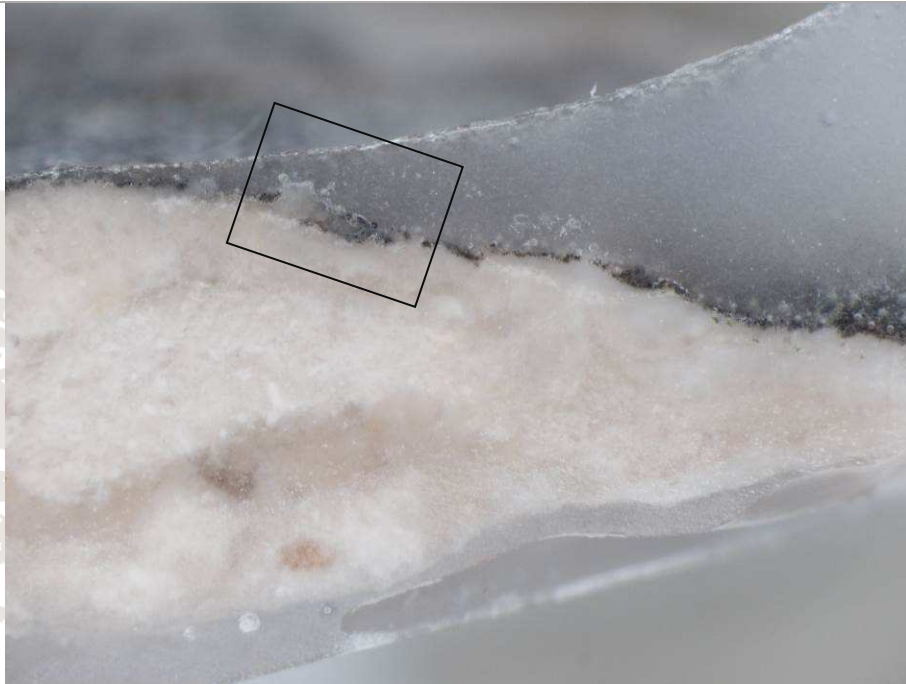
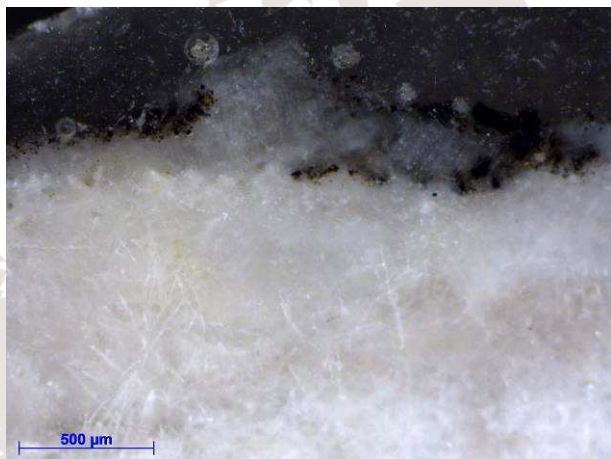
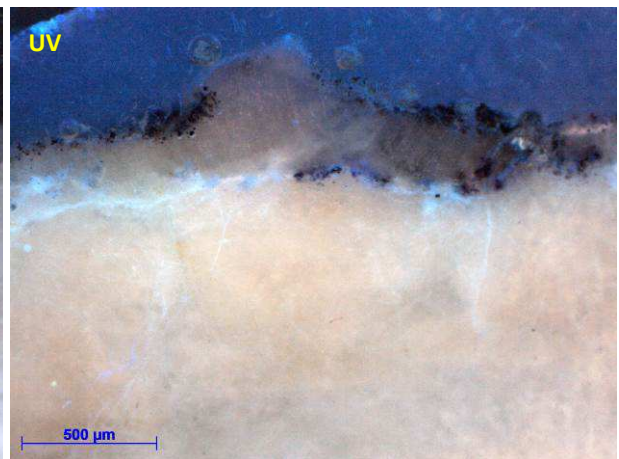
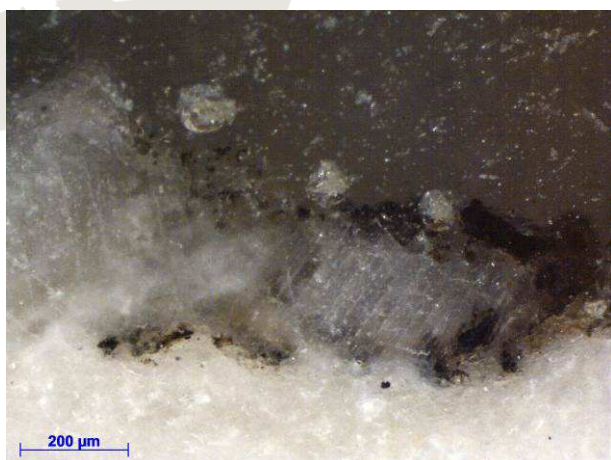
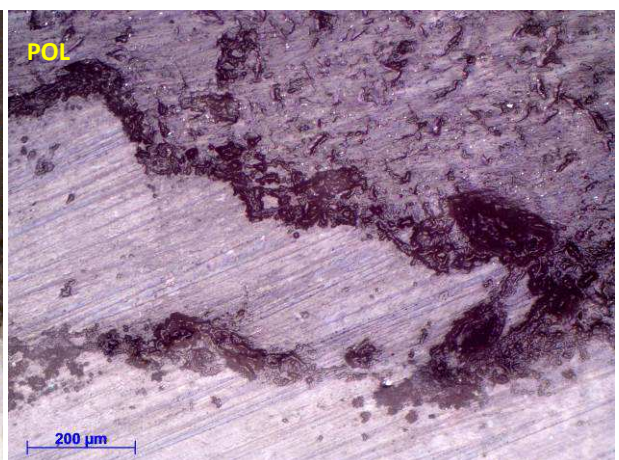
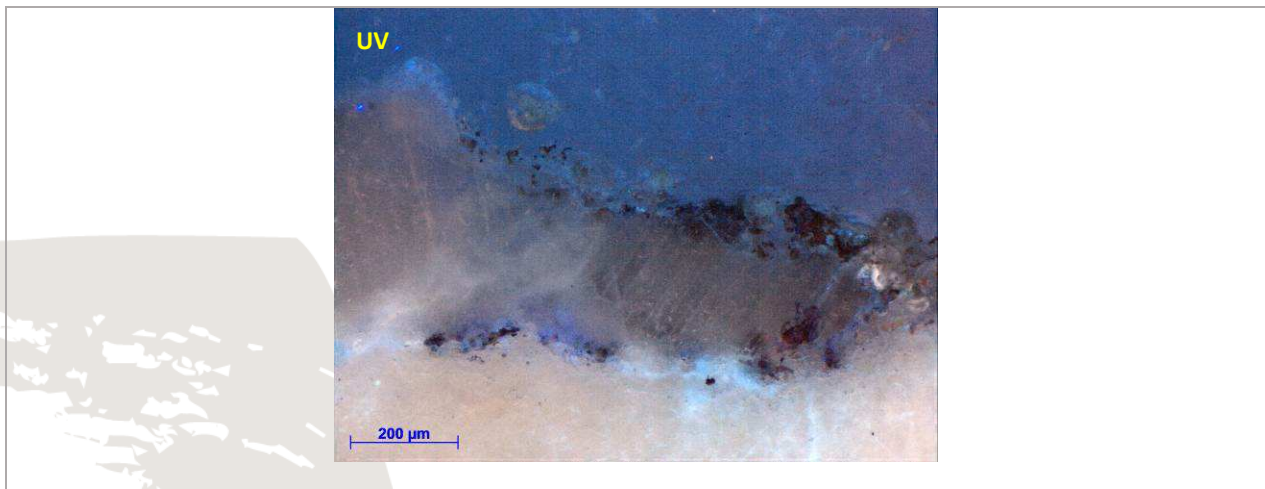
Sample: Ita1 Trebiciano 107 – Roof – mag. 20X

Damages in the structure are visible in the first millimeter beneath the exposed stone surface due to the presence of lichens whose growth caused fissure of limestone crystals. UV light points out the structure alterations and deposition of crystallized CaCO_3 in the fissures while with polarized light limits of the same zone are clearly highlighted.
