Platy limestone as cultural heritage

Annex 3.2

Analysis of Platy Limestone Chemical and Mechanical Properties

Istrian Development Agency IDA d.o.o.

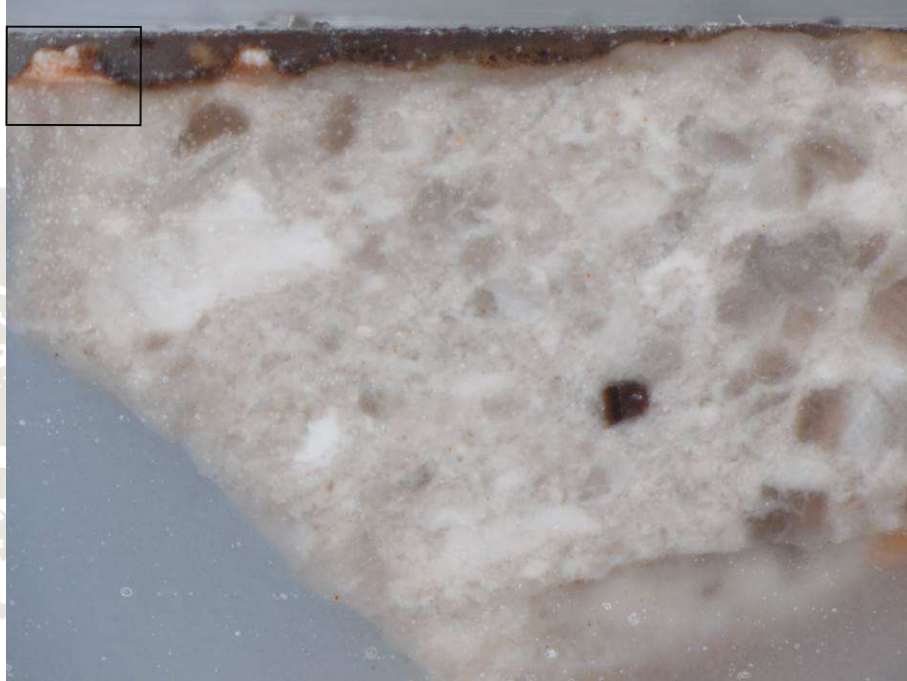
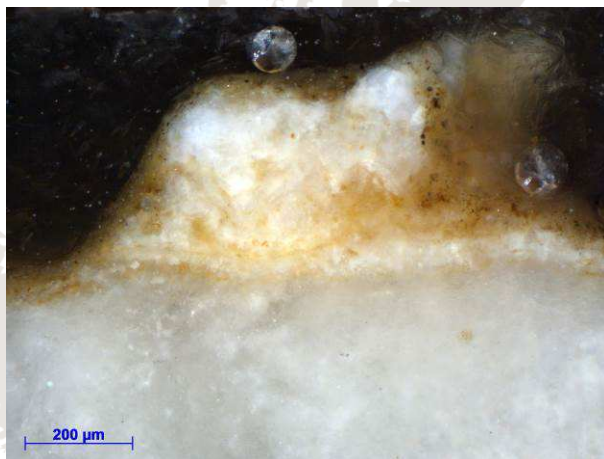
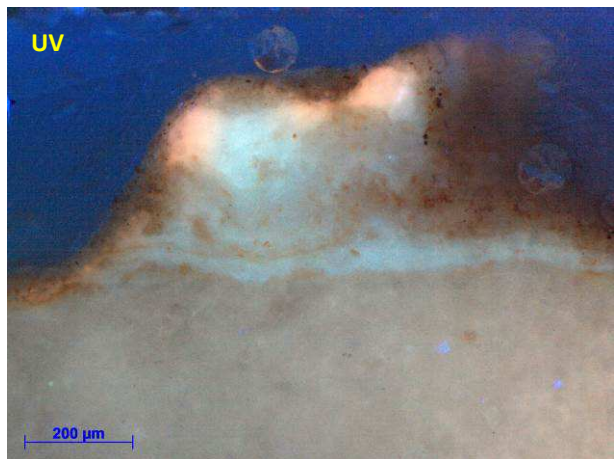
Sample: n.1104 Rupinpiccolo 17 – Roof – mag. 20X

A beige patina is observable on the sample surface. Microscopic analysis point out different UV absorption in several zone on the surface due to the different structure of the recrystallized carbonate on the sample surface.

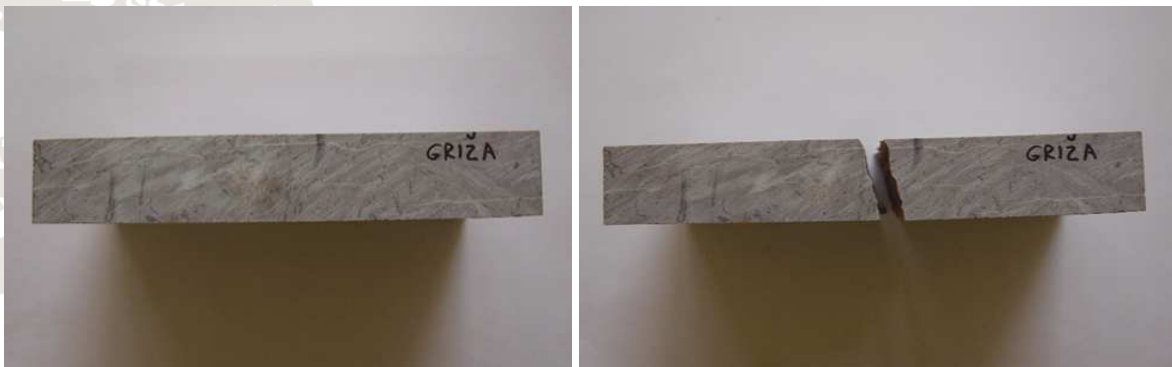
Diagram of the sample Griza sample shows pretension, followed by a continuous increase in stress to about 3 Mpa. After this value, there is a sudden increase of stress to about 6.5 MPa, and the continued growth up to 8 MPa when fracture occurs. This sudden increase in stress can be linked to the properties of materials. Decline of stress values after the fracture is associated with the fact that there has been no complete fracture, the fracture was slowly opening.

Griza sample before and after flexural strength testing.
