Platy limestone as cultural heritage

Annex 3.2

Analysis of Platy Limestone Chemical and Mechanical Properties

Istrian Development Agency IDA d.o.o.

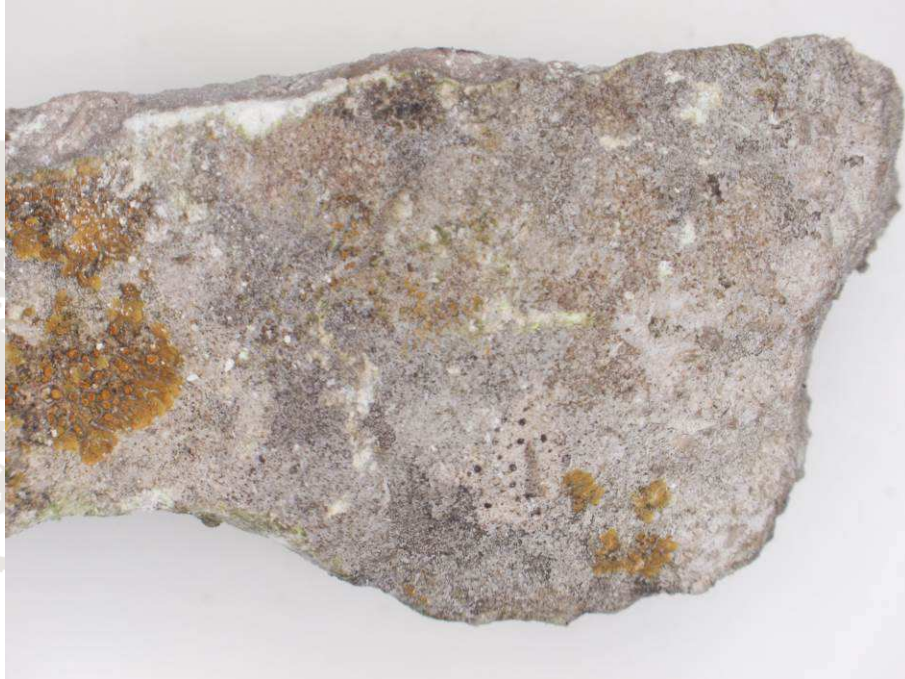
Sample: Slo3 Cerkev Marijinega vnebovzetja na Guri – Roof – mag. 10X

Lichens of various typology are visible on the sample surface

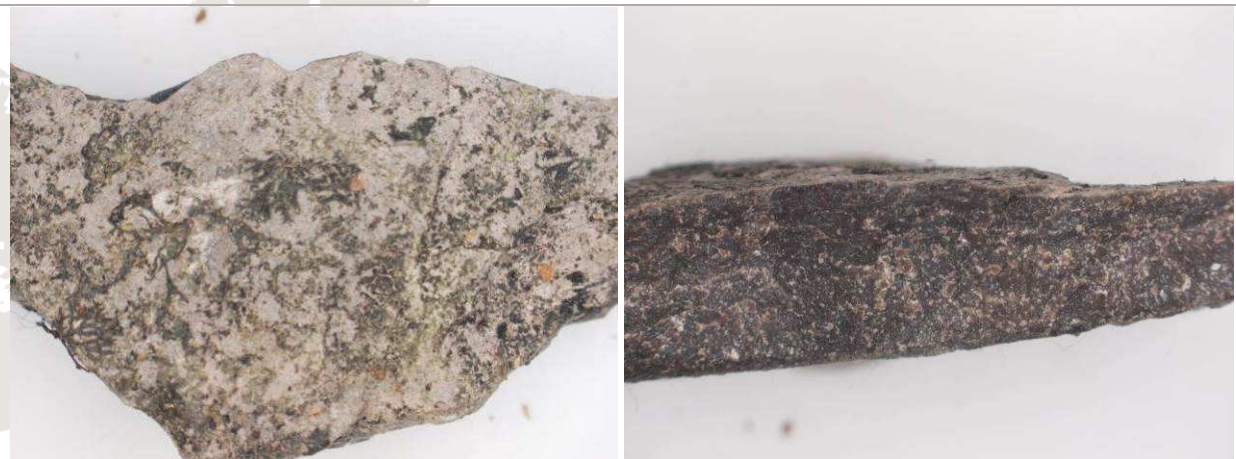
Sample: Slo4 Cerkev Marijinega vnebovzetja – Roof – mag. 10X

Lichens of various typology are visible on the sample surface. The bulk of the sample has a darker coloration than the surface.

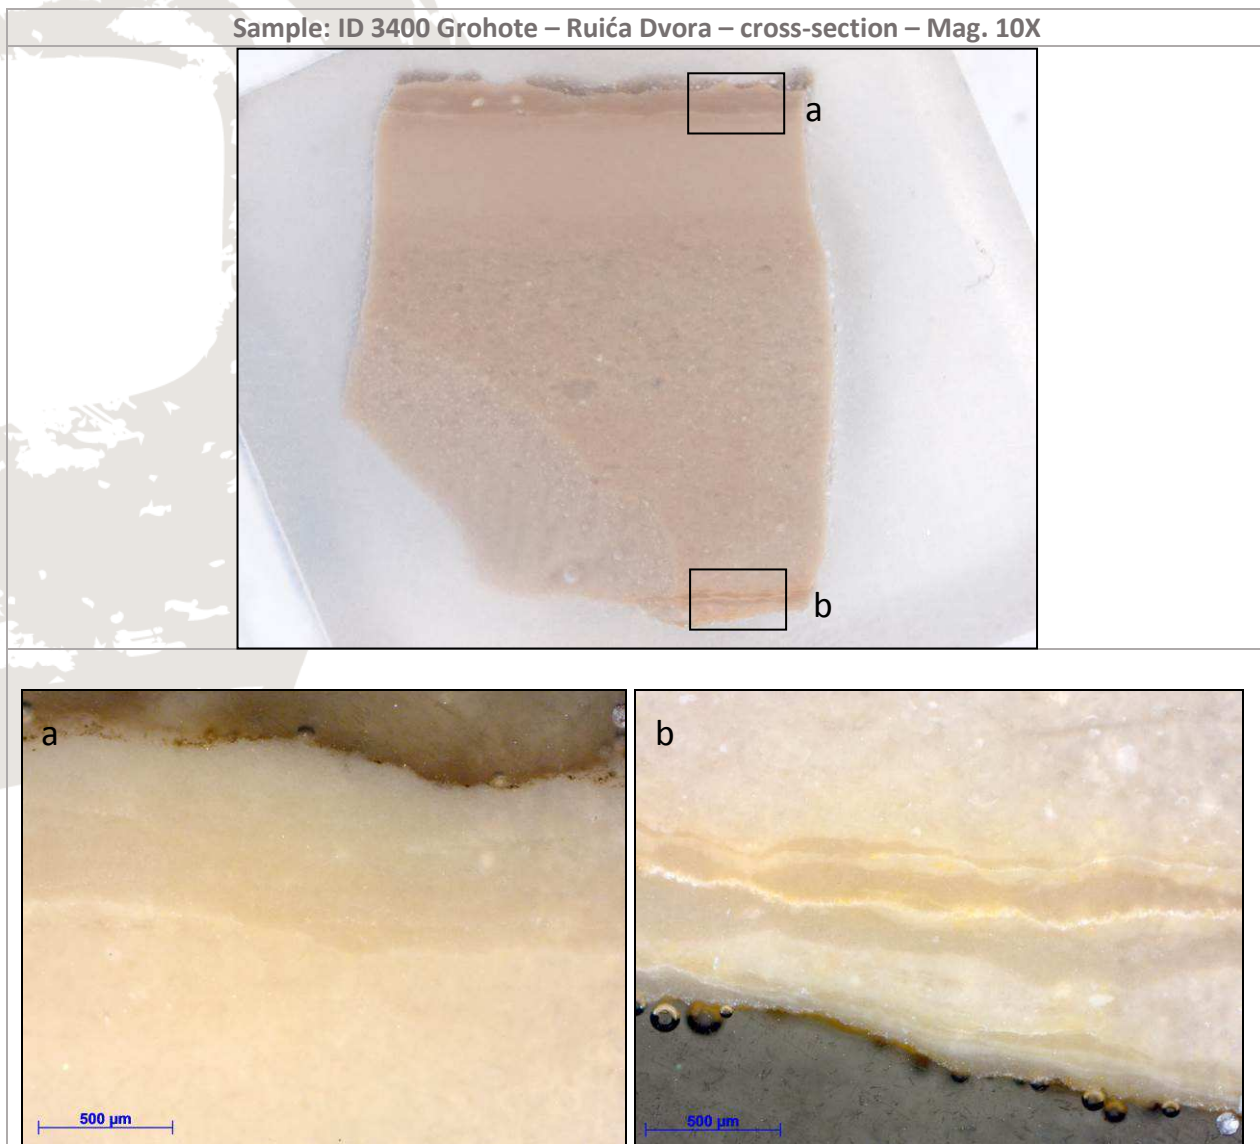
On the sample there is visible a layered structure. The two exposed surfaces of the sample both present some alterations, which manifest themselves in the stratification of the surface structure of the stone in the first 500 microns of the sample bulk. The surface patina has no significant thickness, no considerable biodegradation or crusts are observable.

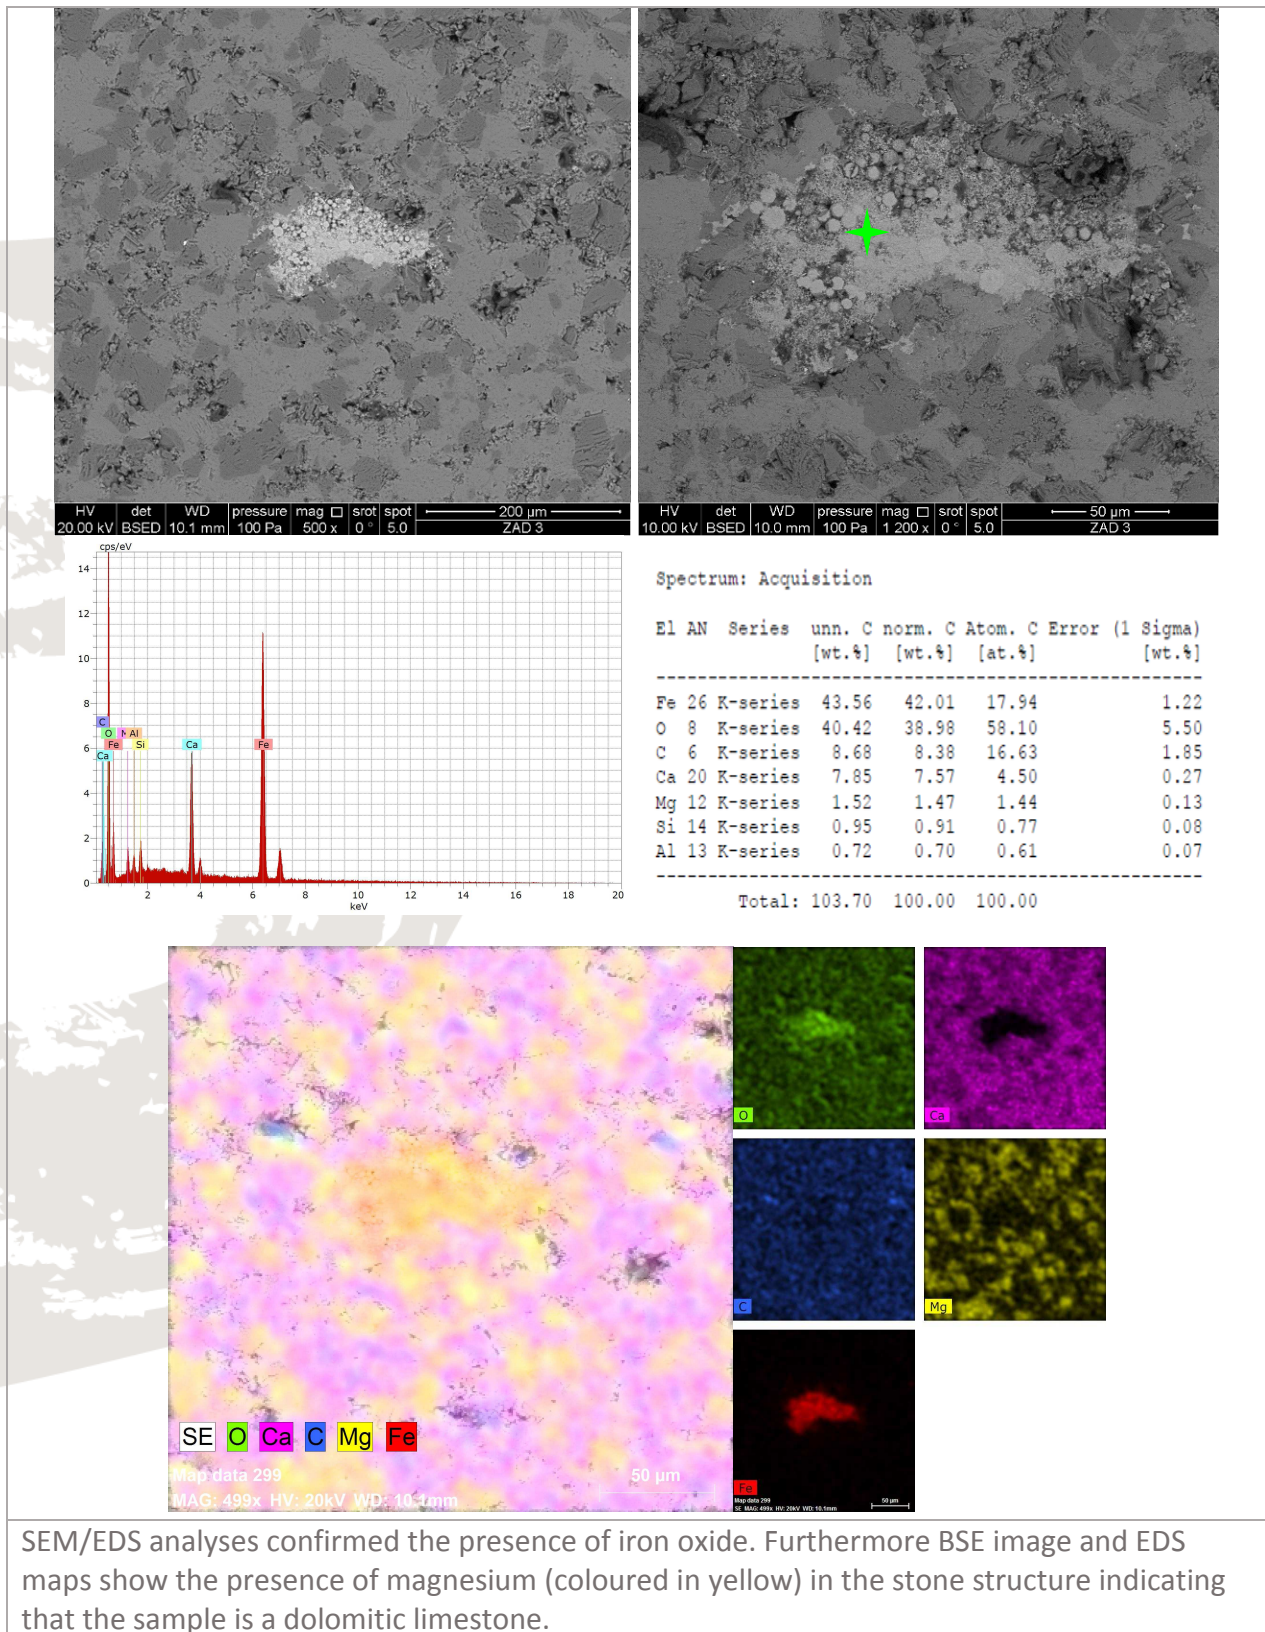
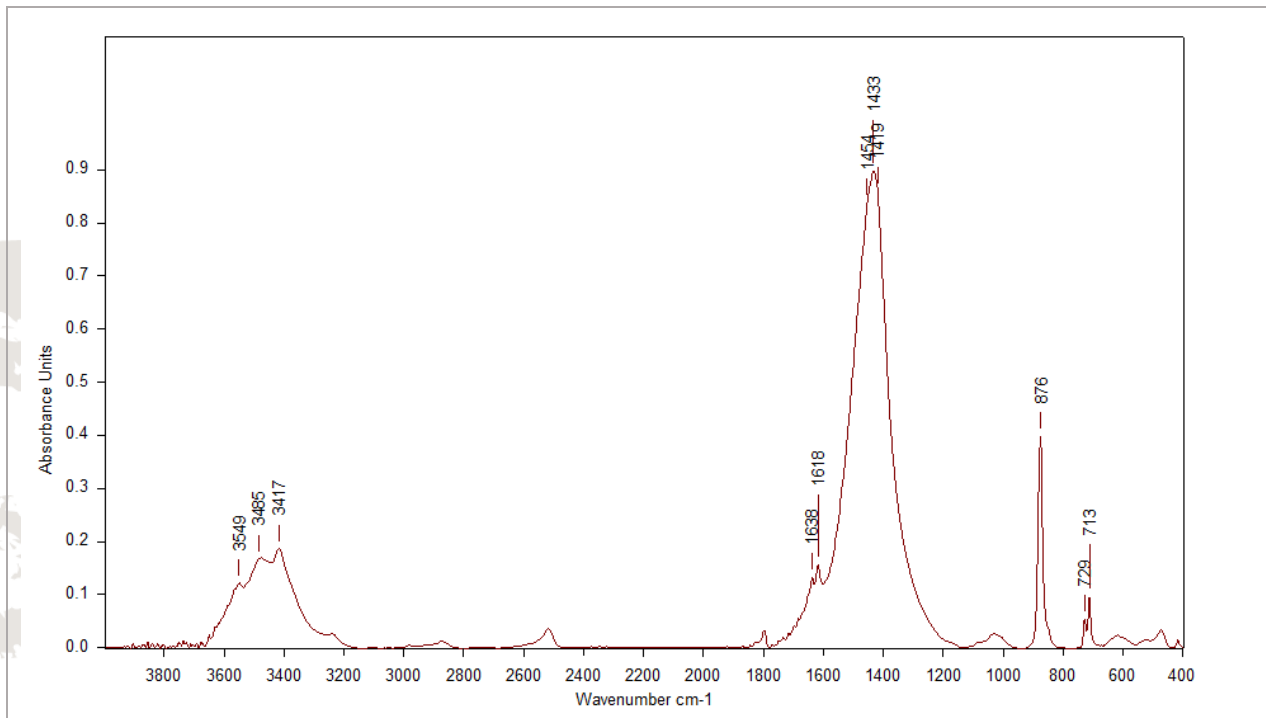
FT-IR spectra of the sample ZAD 3 shows typical calcite bands: at 1433 cm^{-1} stretching of the C-O bonds in the carbonate ion is observable, while bands at 876 and 713 cm^{-1} correspond to the bending of CO_3^{2-} ion. The band at 729 cm^{-1} indicates the in-plane bending mode (ν_4) of CO_3^{2-} in the dolomite structure. Bands in the zone 3550 – 3415 cm^{-1} correspond to water molecules present as humidity.

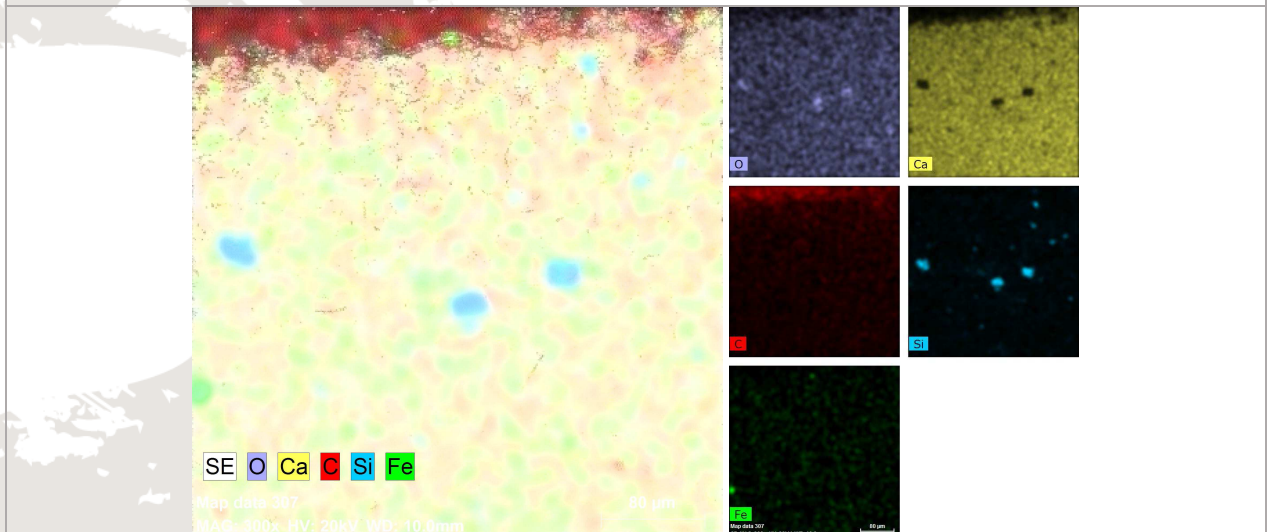
EDS map shows no change in composition on the stone surface, just a lowering in the calcium concentration has been registered. Single element maps illustrate the presence of silicon oxide particles, as well as iron oxide inclusions.

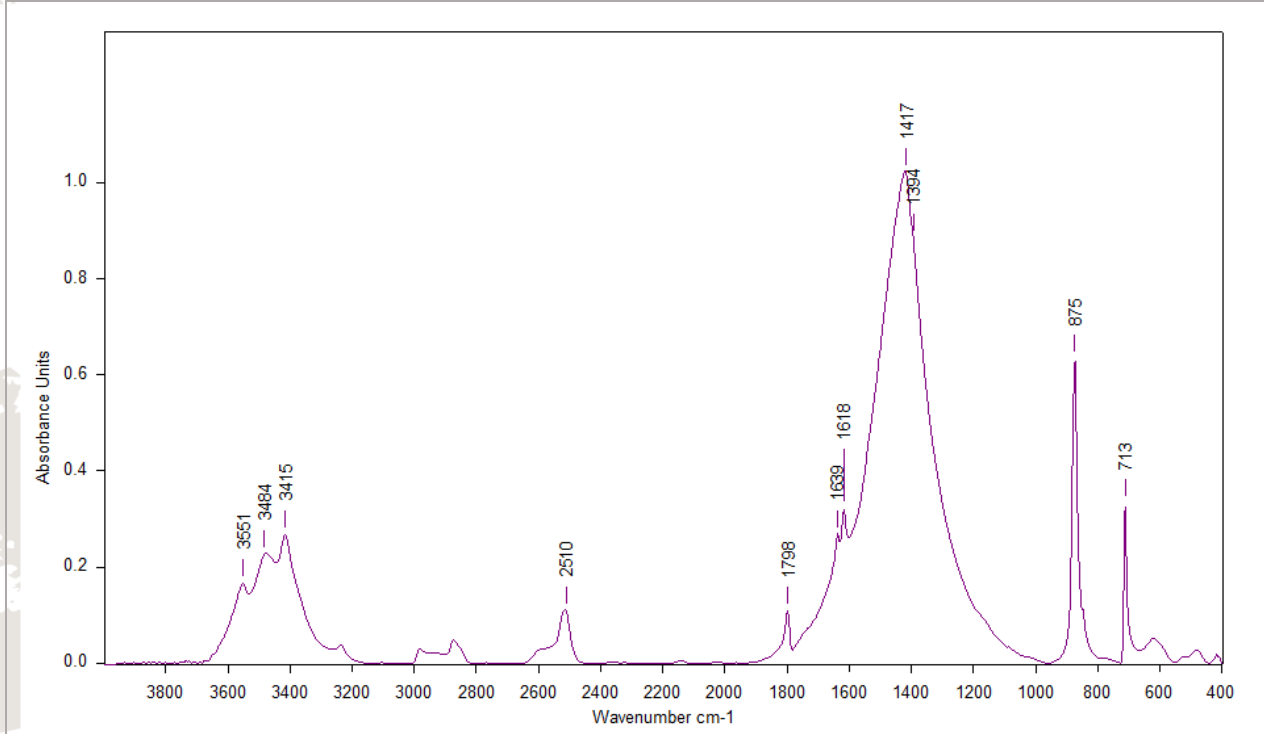
FT-IR spectra of Slo1 sample shows calcite bands at 1417 cm⁻¹ stretching of the C-O bonds in the carbonate ion is present, bands at 876 and 713 cm⁻¹ correspond to the bending of CO₃²⁻ ion. Bands in the zone 3550 – 3415 cm⁻¹ correspond to water molecules present as humidity.

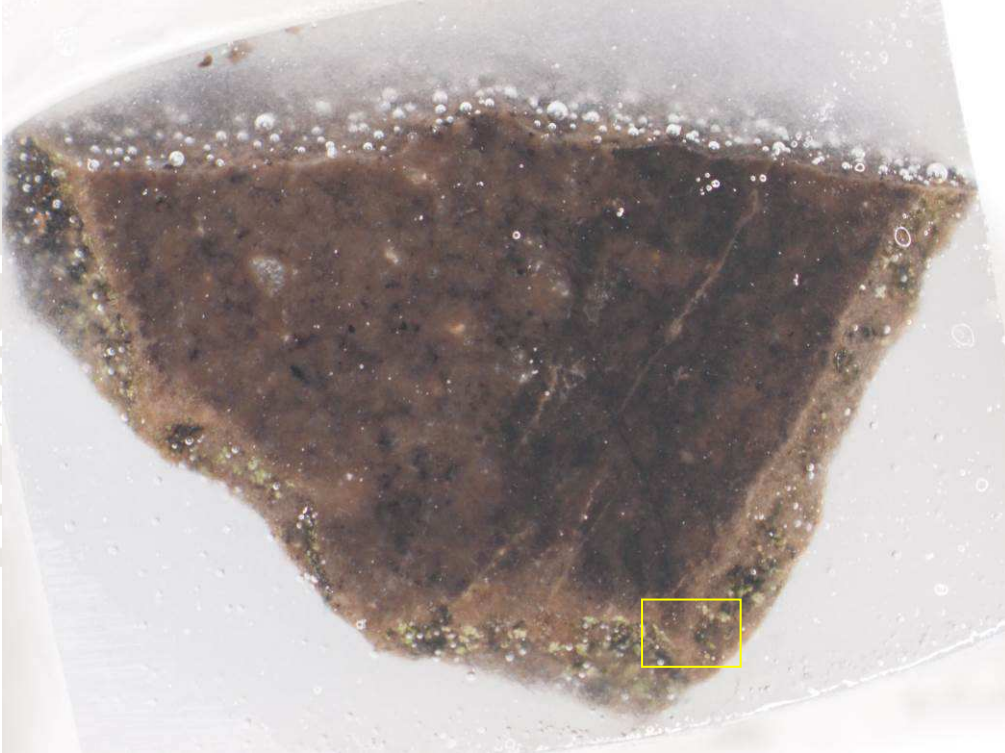
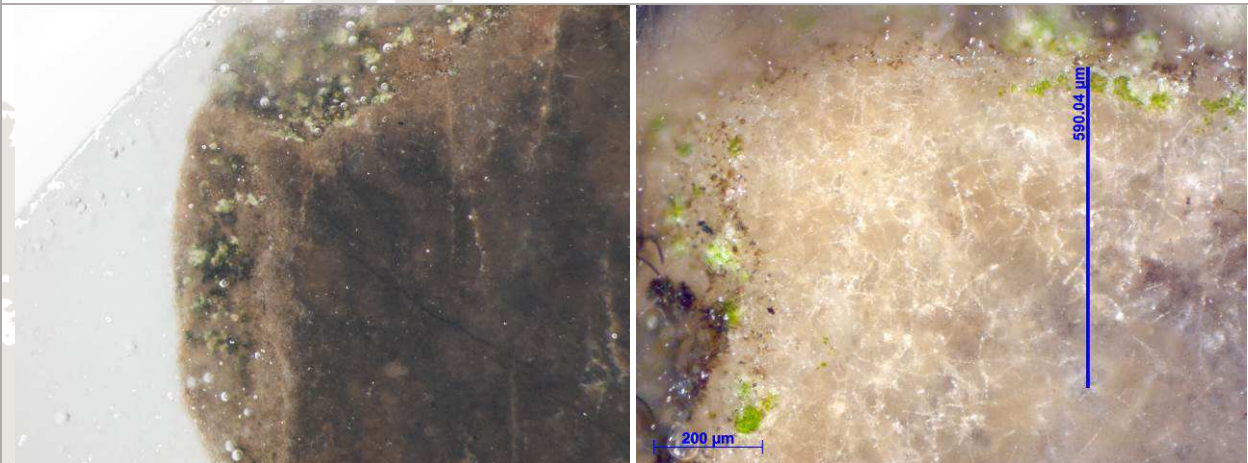
Sample: Slo4 Cerkev Marijinega vnebovzetja – Roof – mag. 12X

On the studied sample a slightly discoloration of the rock on the surface has been noticed, due to hyphae of endolithic lichens present on the rock surface. The colonization of the studied sample goes up to more than half millimeter in the rock structure increasing the porosity and damaging the carbonate structure.

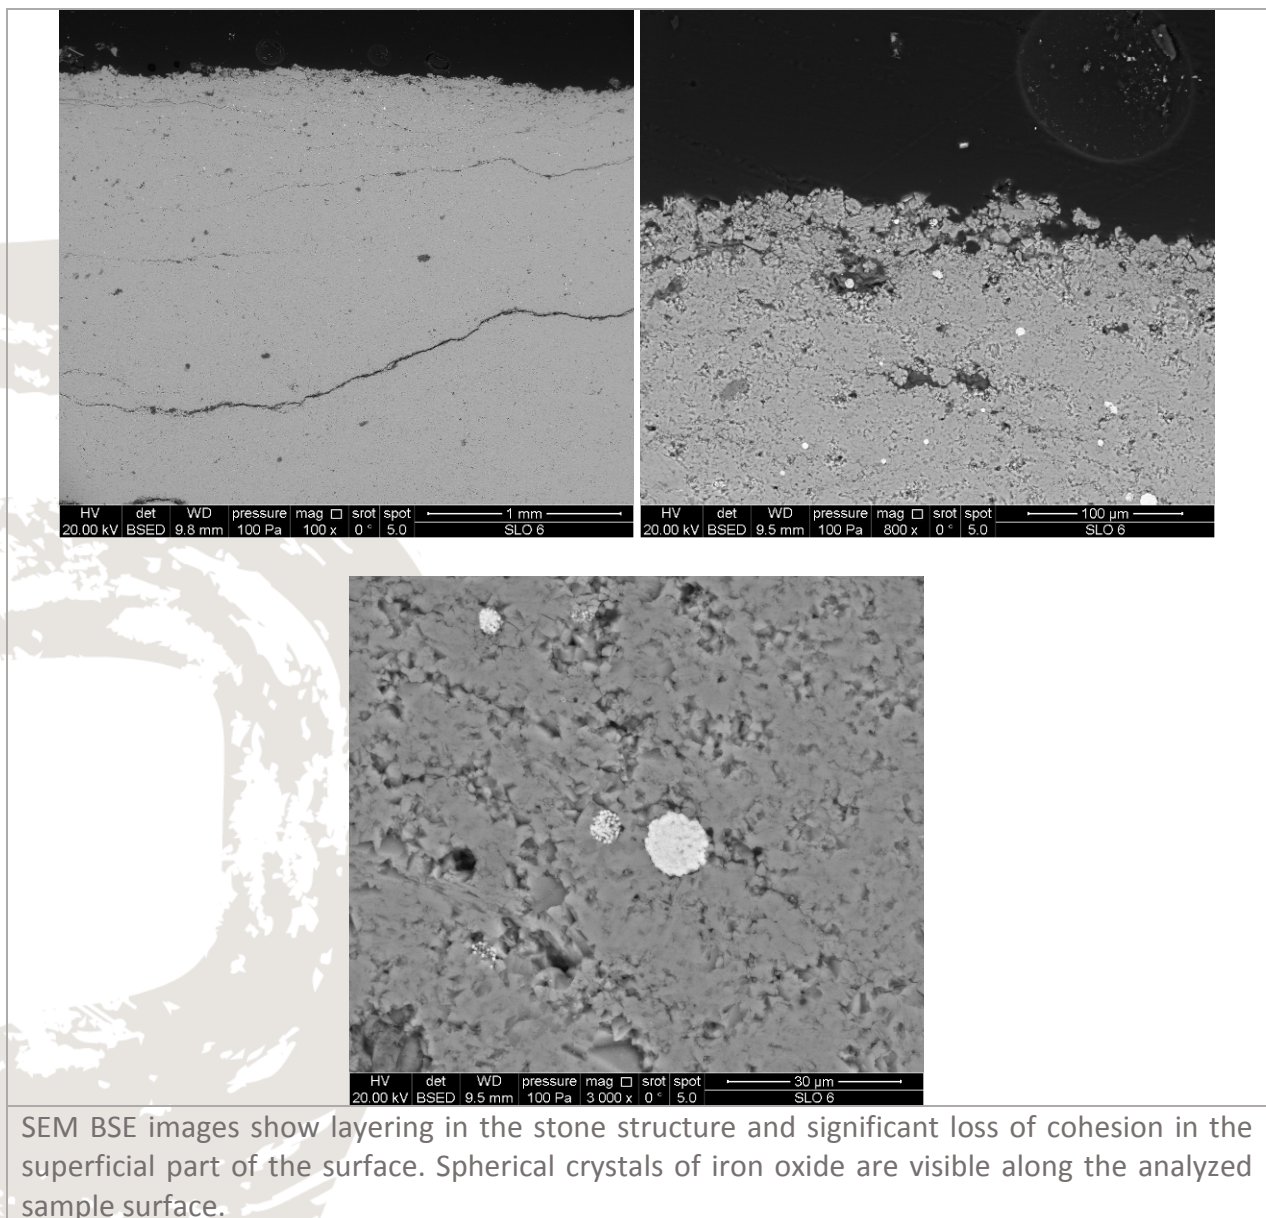
Significant stratification of the lithotype is visible in the studied sample as well as superficial discoloration although any patina of biological origin is present. Orange colored crystals are visible along the first 1000 micrometers of the sample cross-section.

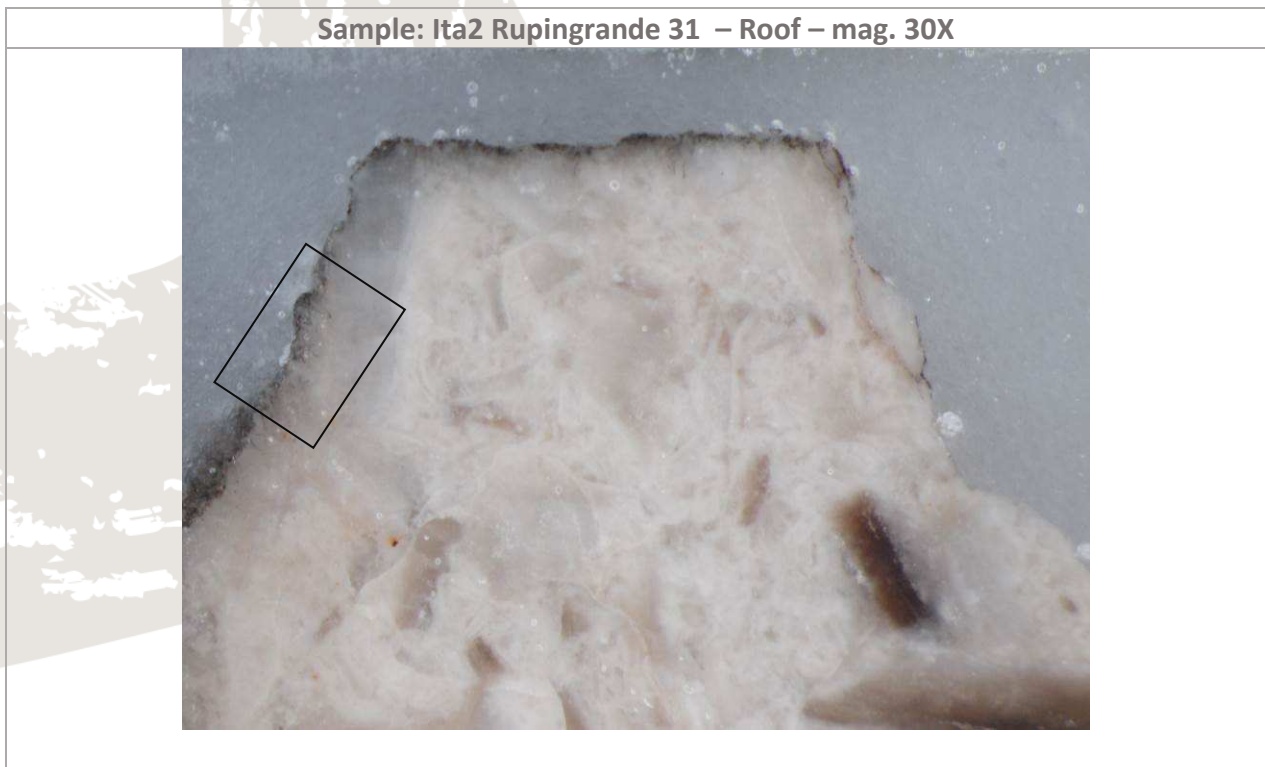
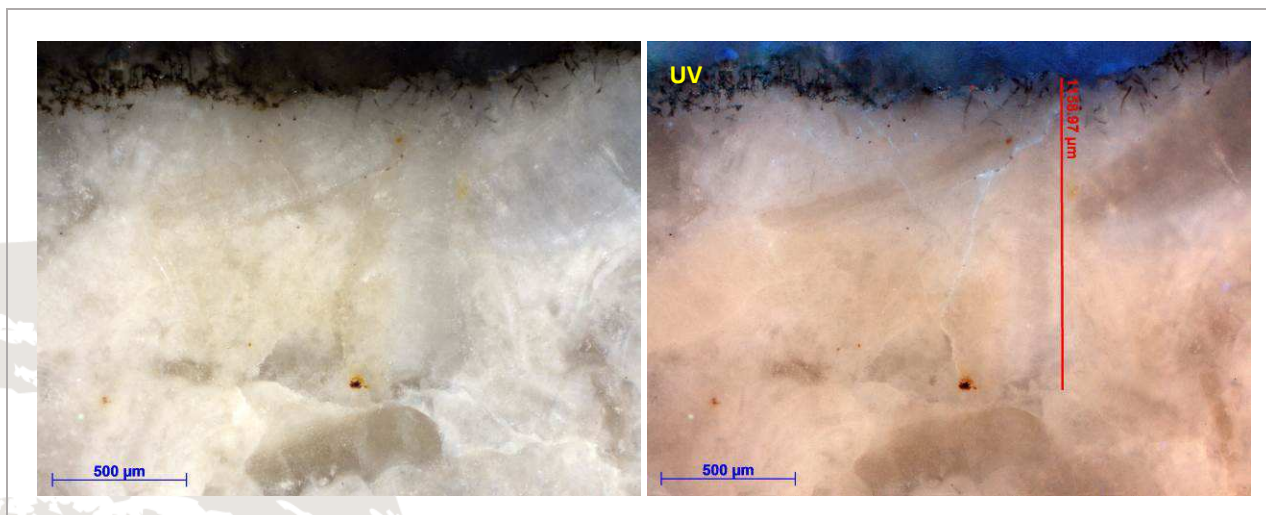
Fractures of the stone structure are visible up to 1 millimeter beneath the exposed surface of the analyzed sample. UV light points out the fractures, where recrystallized carbonate is probably present. Roots of lichen colonies are visible on the sample surface.

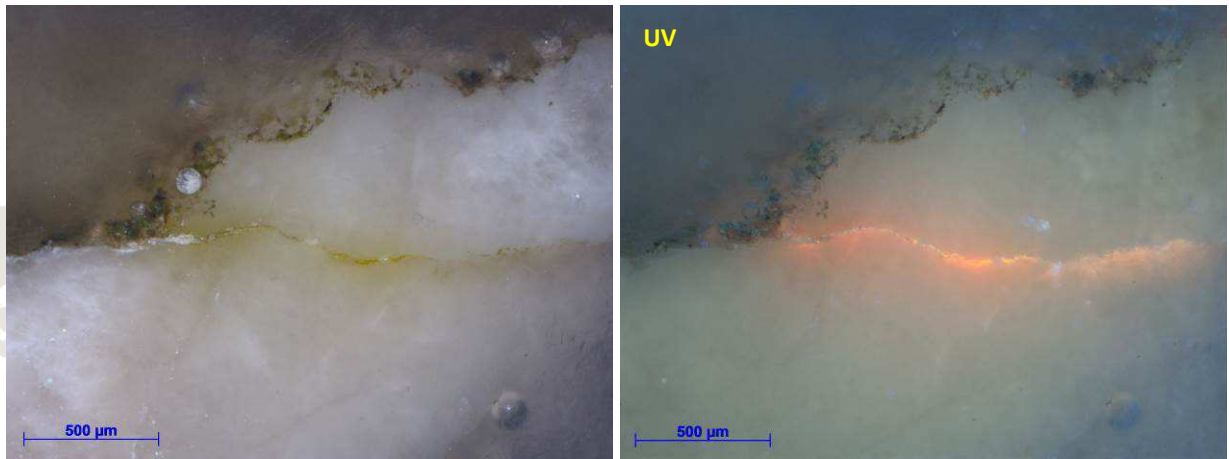
Lichens colonies are present on the stone surface as well as fissures are visible. Strong orange absorption in the crack due to infiltrations of solubilized and recrystallized CaCO_3 .

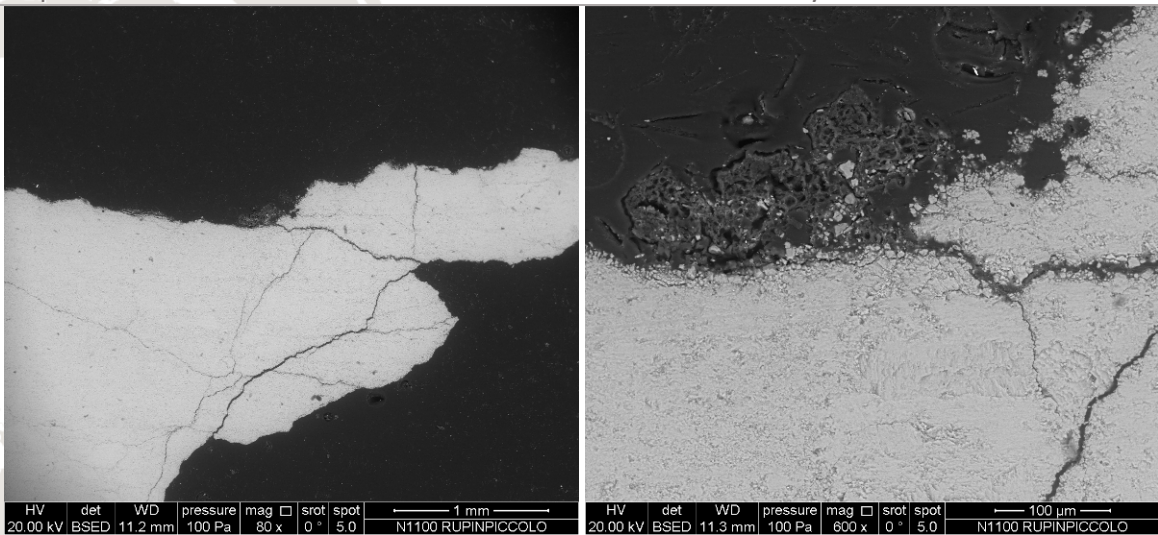
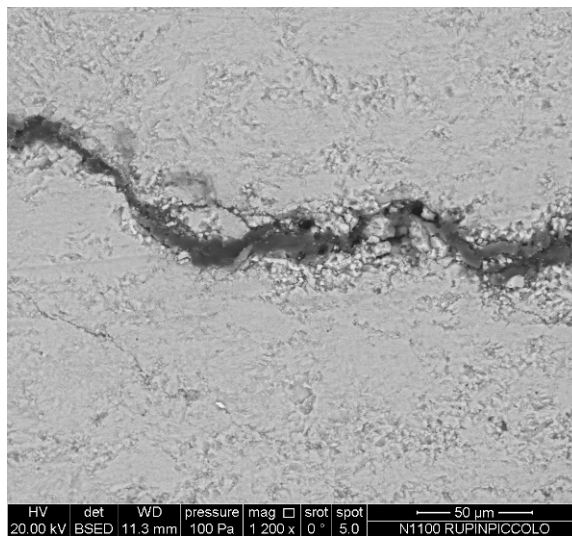
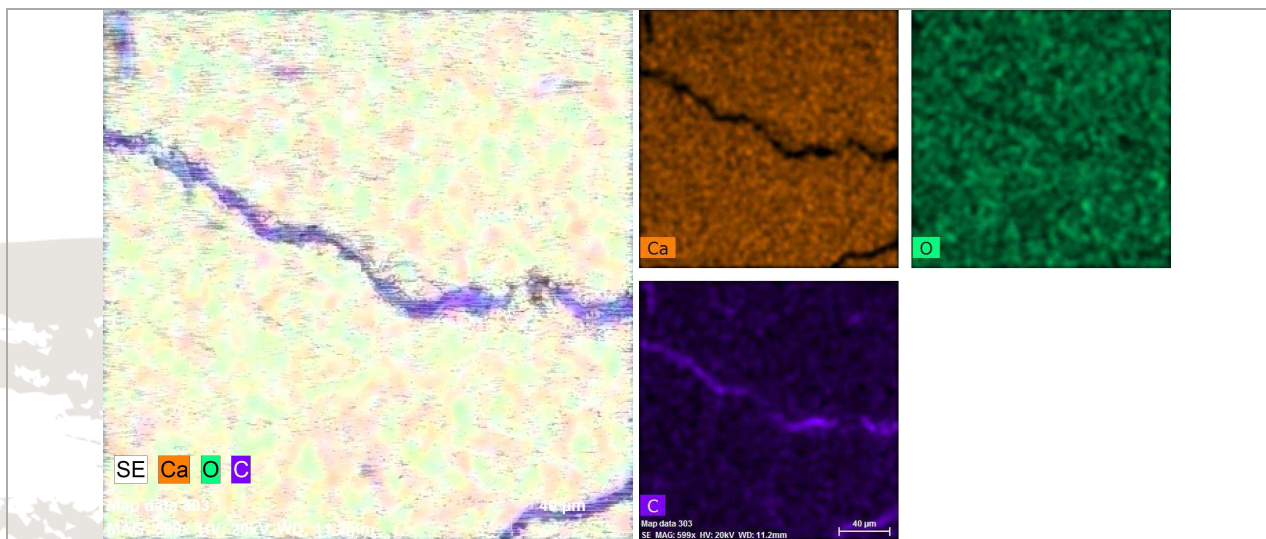
SEM/EDS analyses show no changes in composition in the observed fissure. The higher concentration of carbon presented in elemental maps, is due to the infiltration of the embedding resin. These results confirm the assumption of solubilized and recrystallized carbonate deposited in the fissure.

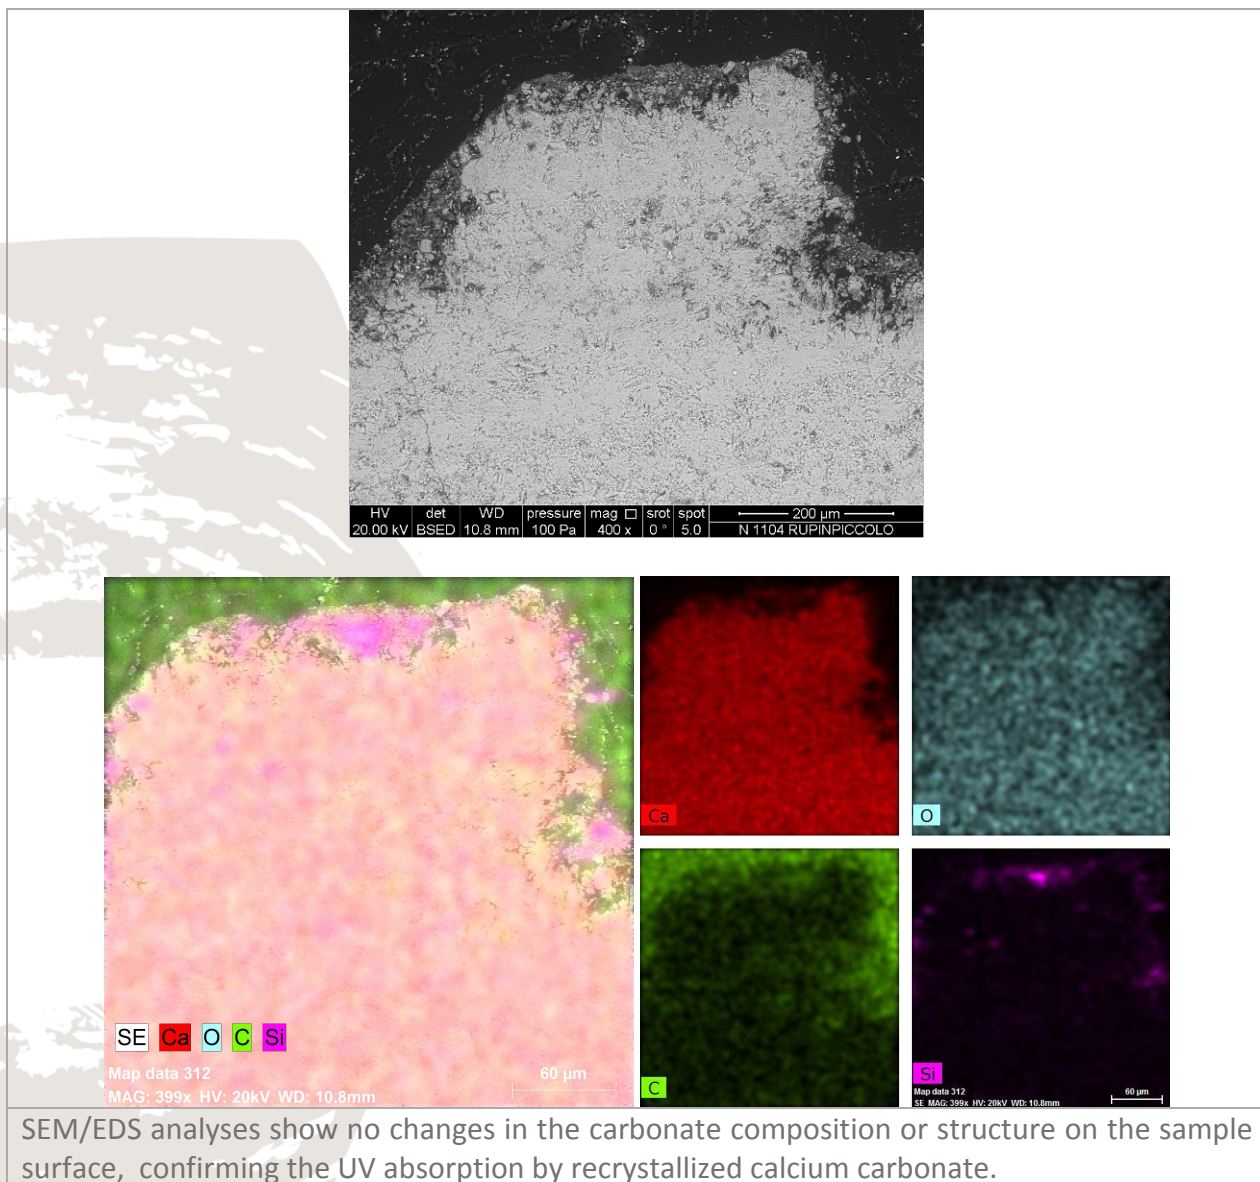
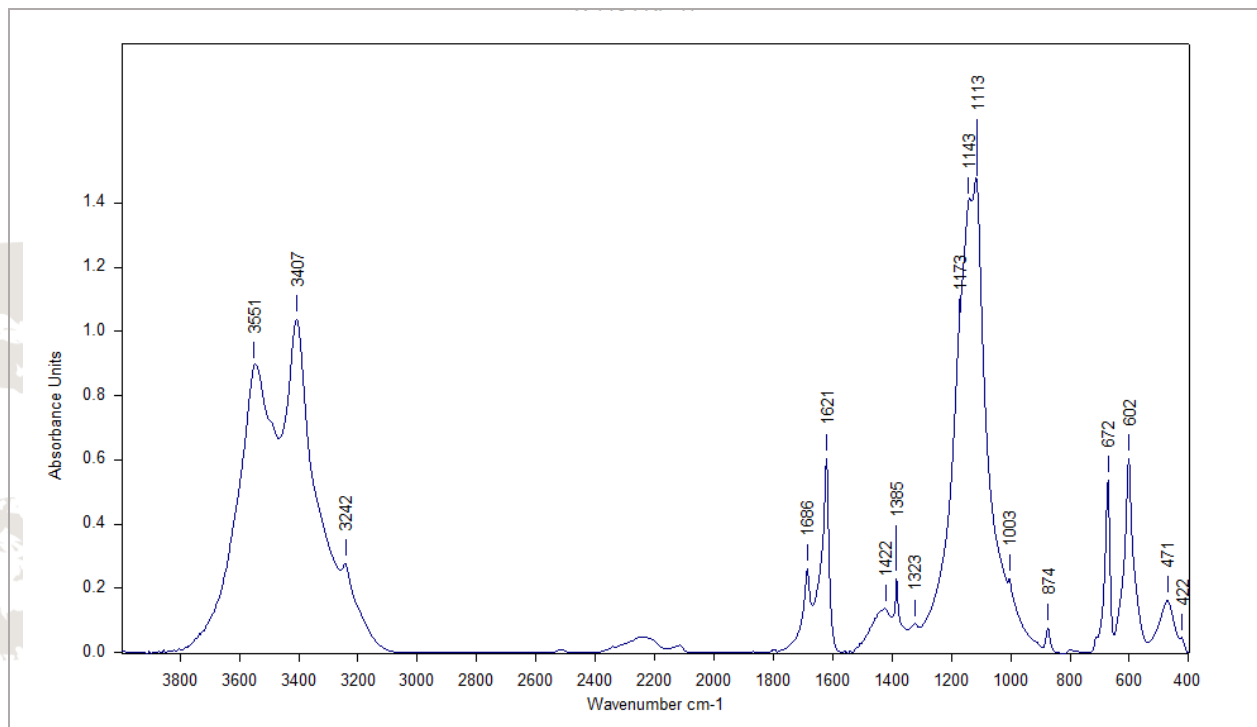
By means of SEM/EDS a portion of sample without sulfur was analyzed, for FT-IR analysis from another part of the sample, some superficial patina was taken and the spectrum obtained shows that it was made mainly of calcium sulphate dihydrate (gypsum). Peaks at 1143 cm⁻¹ and 1113 cm⁻¹ indicate asymmetric SO₄²⁻ stretching band while at 672 cm⁻¹ and 602 cm⁻¹ designate the bending band of the SO₄²⁻ ion. A narrow peak at 1385 cm⁻¹ could be related to nitrates. Low intensity calcite peaks are observable in the spectrum as well.

Only on the surface of sample n. 1104 Rupinpiccolo 17 a sulphatic patina was found.

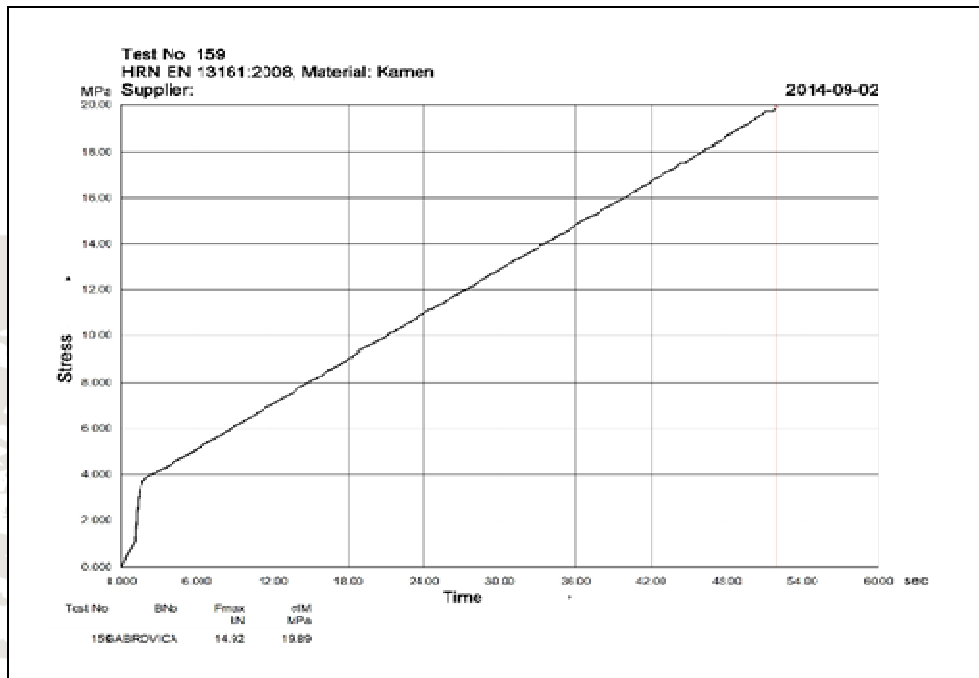
Bending test diagram of Gabrovica sample

Bending test diagram of sample *Gabrovica* shows a constant increase in stress until fracture. Fracture appeared at stress of 20 Mpa. The first part of the diagram shows the pretension of 1 MPa and a further increase of stress after which it becomes constant until fracture occurs.

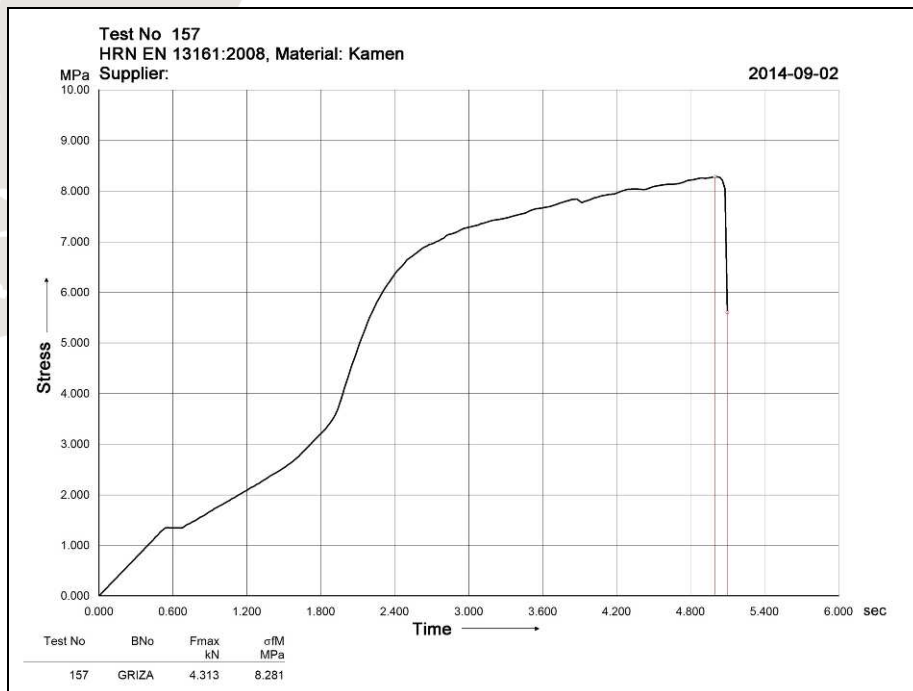
Bending test diagram of Griza sample

Diagram of the sample Griza sample shows pretension, followed by a continuous increase in stress to about 3 Mpa. After this value, there is a sudden increase of stress to about 6.5 MPa, and the continued growth up to 8 MPa when fracture occurs. This sudden increase in stress can be linked to the properties of materials. Decline of stress values after the fracture is associated with the fact that there has been no complete fracture, the fracture was slowly opening.
