# **Platy limestone as cultural heritage**

### **Cross-border issues in conservation and restoration of platy limestone**

### **Final report for the project area in Slovenia (Kras)**

February 2015

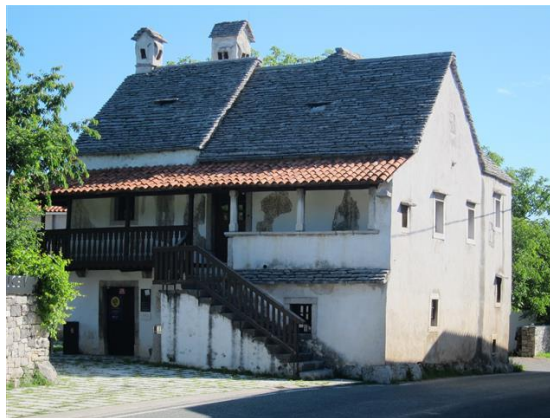
Figure 1  
Divača, Štrekelj homestead, reconstructed in a Museum of Slovenian Film Actors (photo Mitja Guštin, 2015).

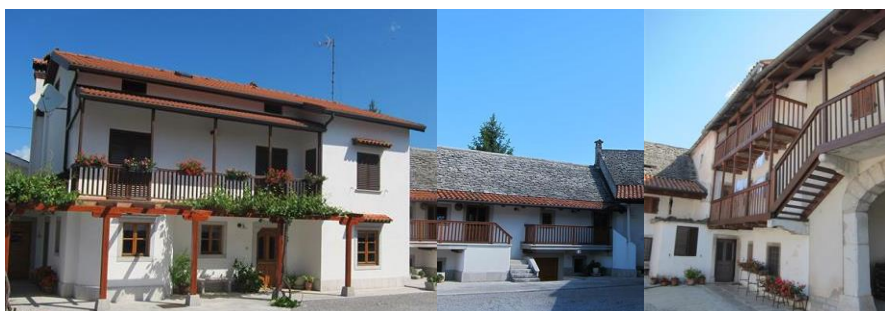
Figure 2

Žirje, a noble, well-preserved homestead. The main house is on the right and dates into 1790 (photo Mitja Guštin 2013)

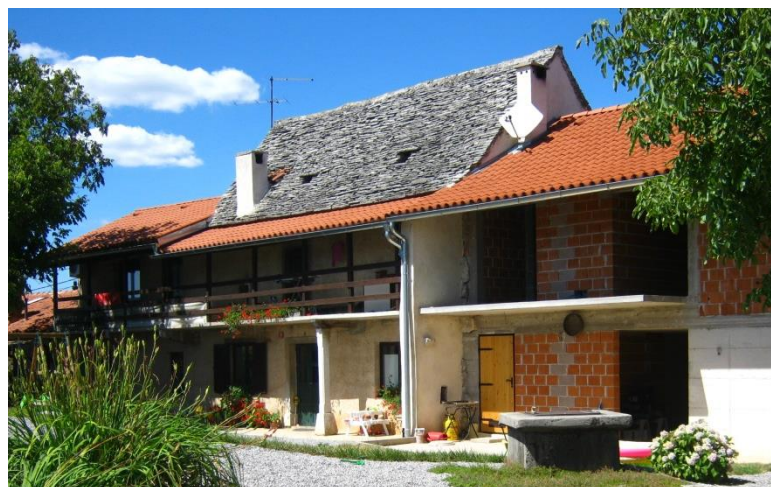
Figure 3

Kazlje 10, a modern example of integration of the old building with the roof of platy limestone with a newly built extension (photo Mitja Guštin, 2014).

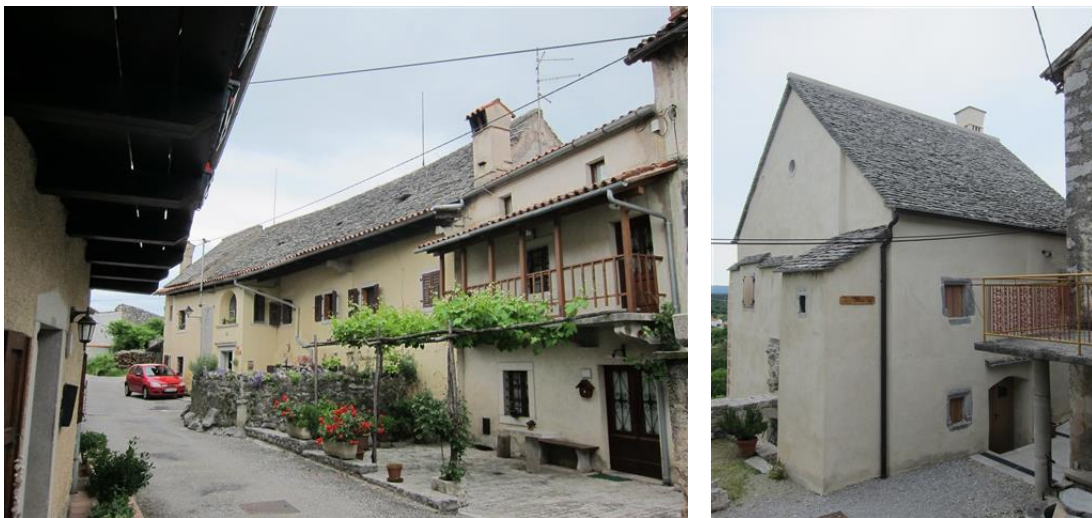
Figure 4

Štanjel, maintenance of an old traditional house (left), and reconstruction of a new building for touristic purposes (photo Mitja Guštin 2013).

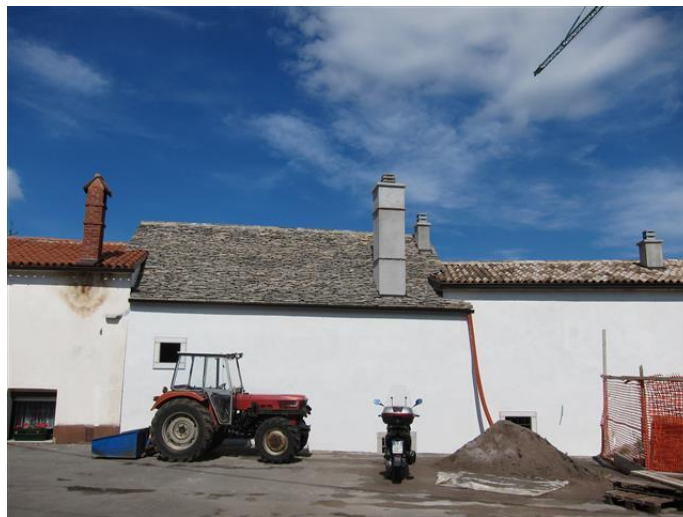
Figure 5  
Gorenje pri Divači, “Pri Maticovih”,  
an example of a recent reconstruction for residential purposes (photo Mitja Guštin 2013).

In several houses the roof was pulled down and consequently rebuilt (for example: homestead "Pri Maticovih" in Gorenje pri Divači). In some cases the stone roof has been reconstructed on an original wooden structure, usually by applying concrete roofing and stone slates, horizontally connected to one another as for example house in Gabrovica pri Črnem Kalu 40. In some cases (like Ražman house, Gračišče), a bituminous layer was lathed between wooden roofing and *skrila/škrile/škrle*, a technique, that has led to structural problems.
